Jun 20th, 2023

1234 Skywalker Drive, Tampa, 34654

# Home Inspection Report

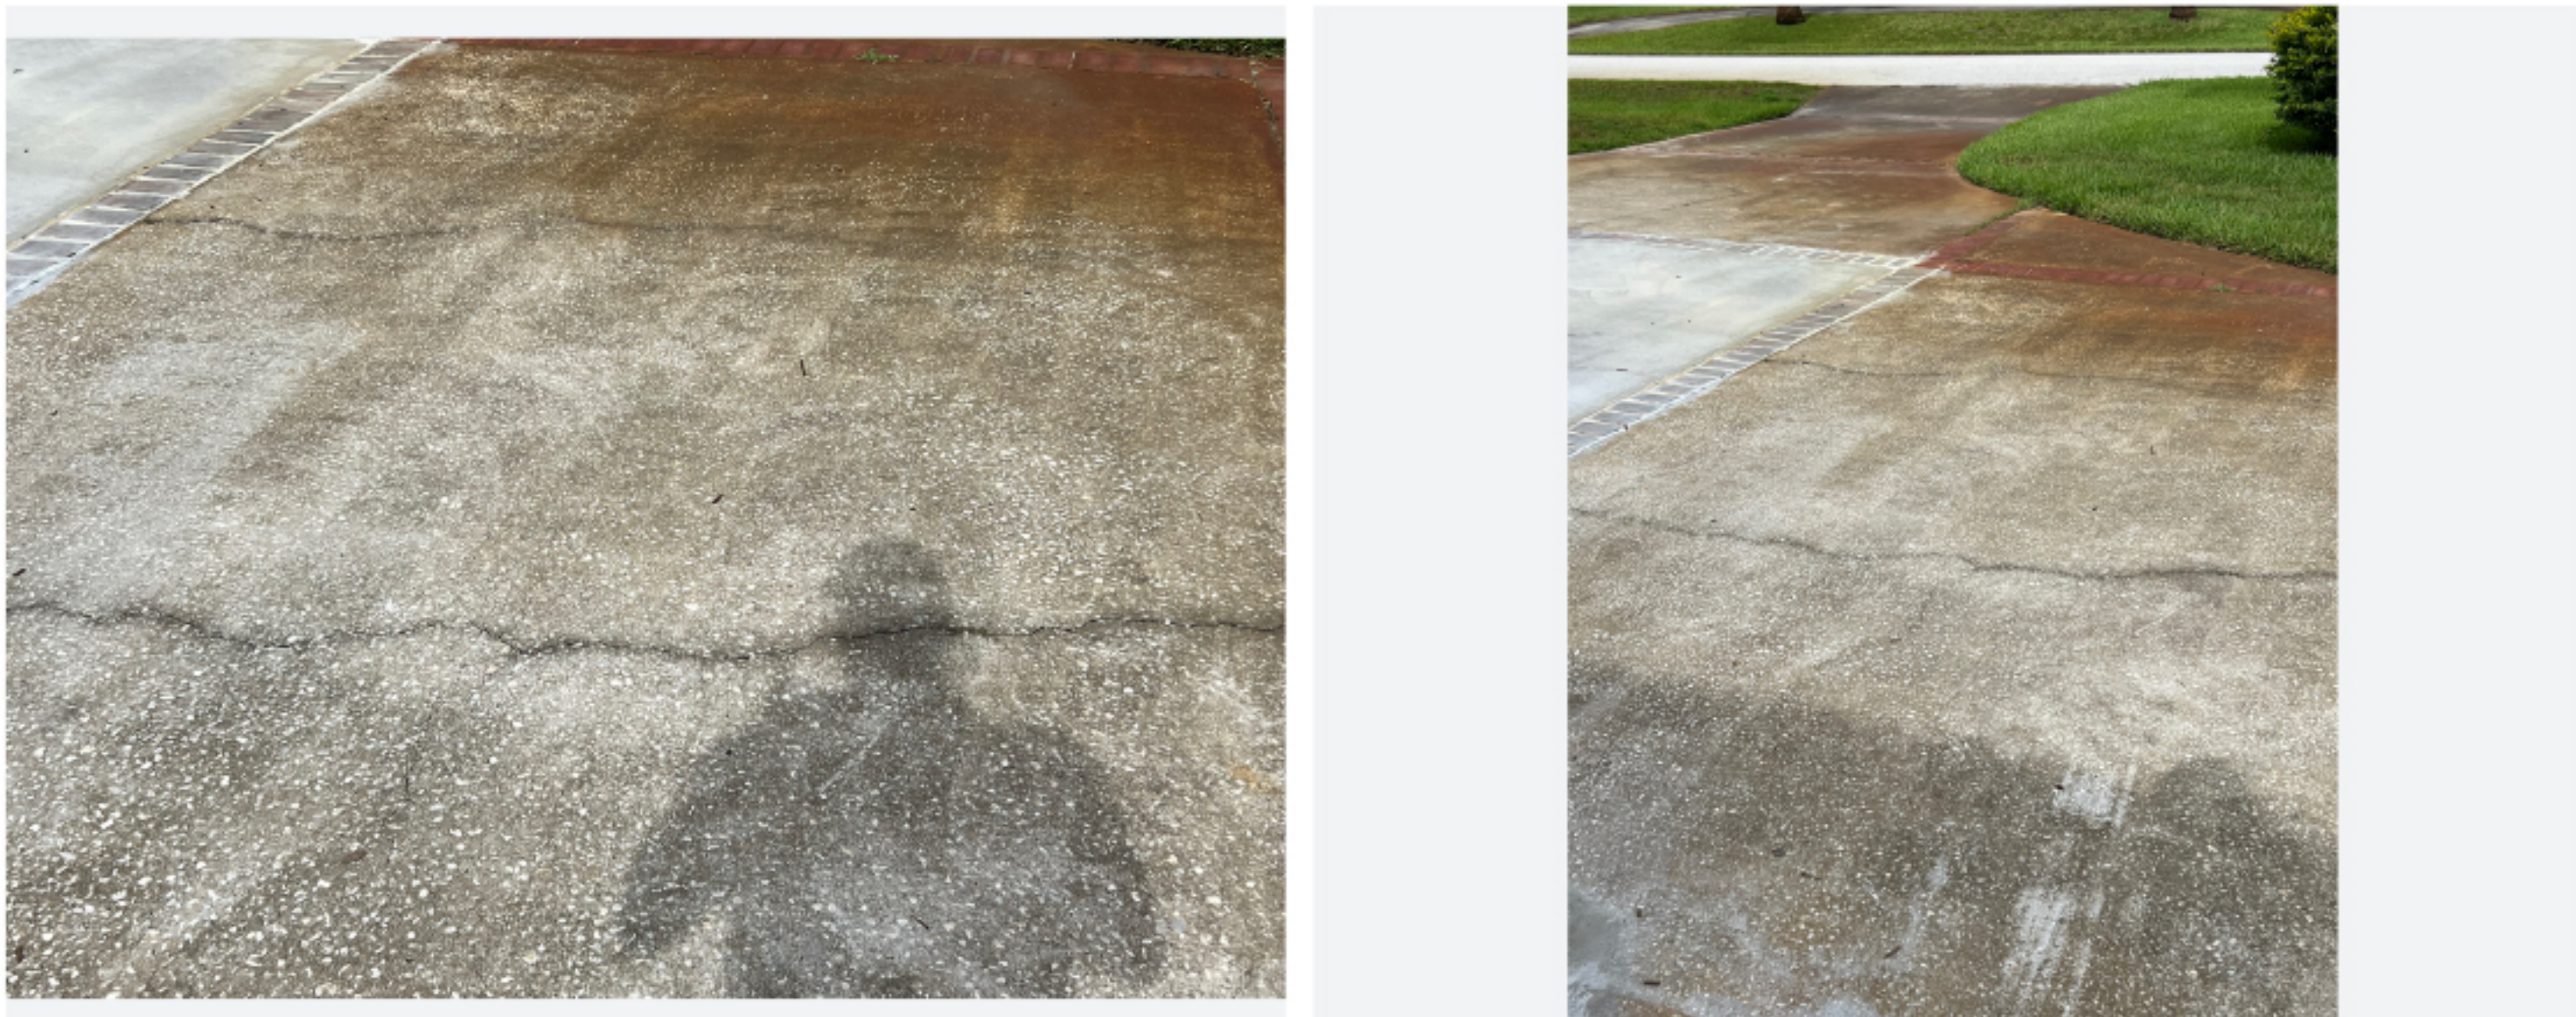
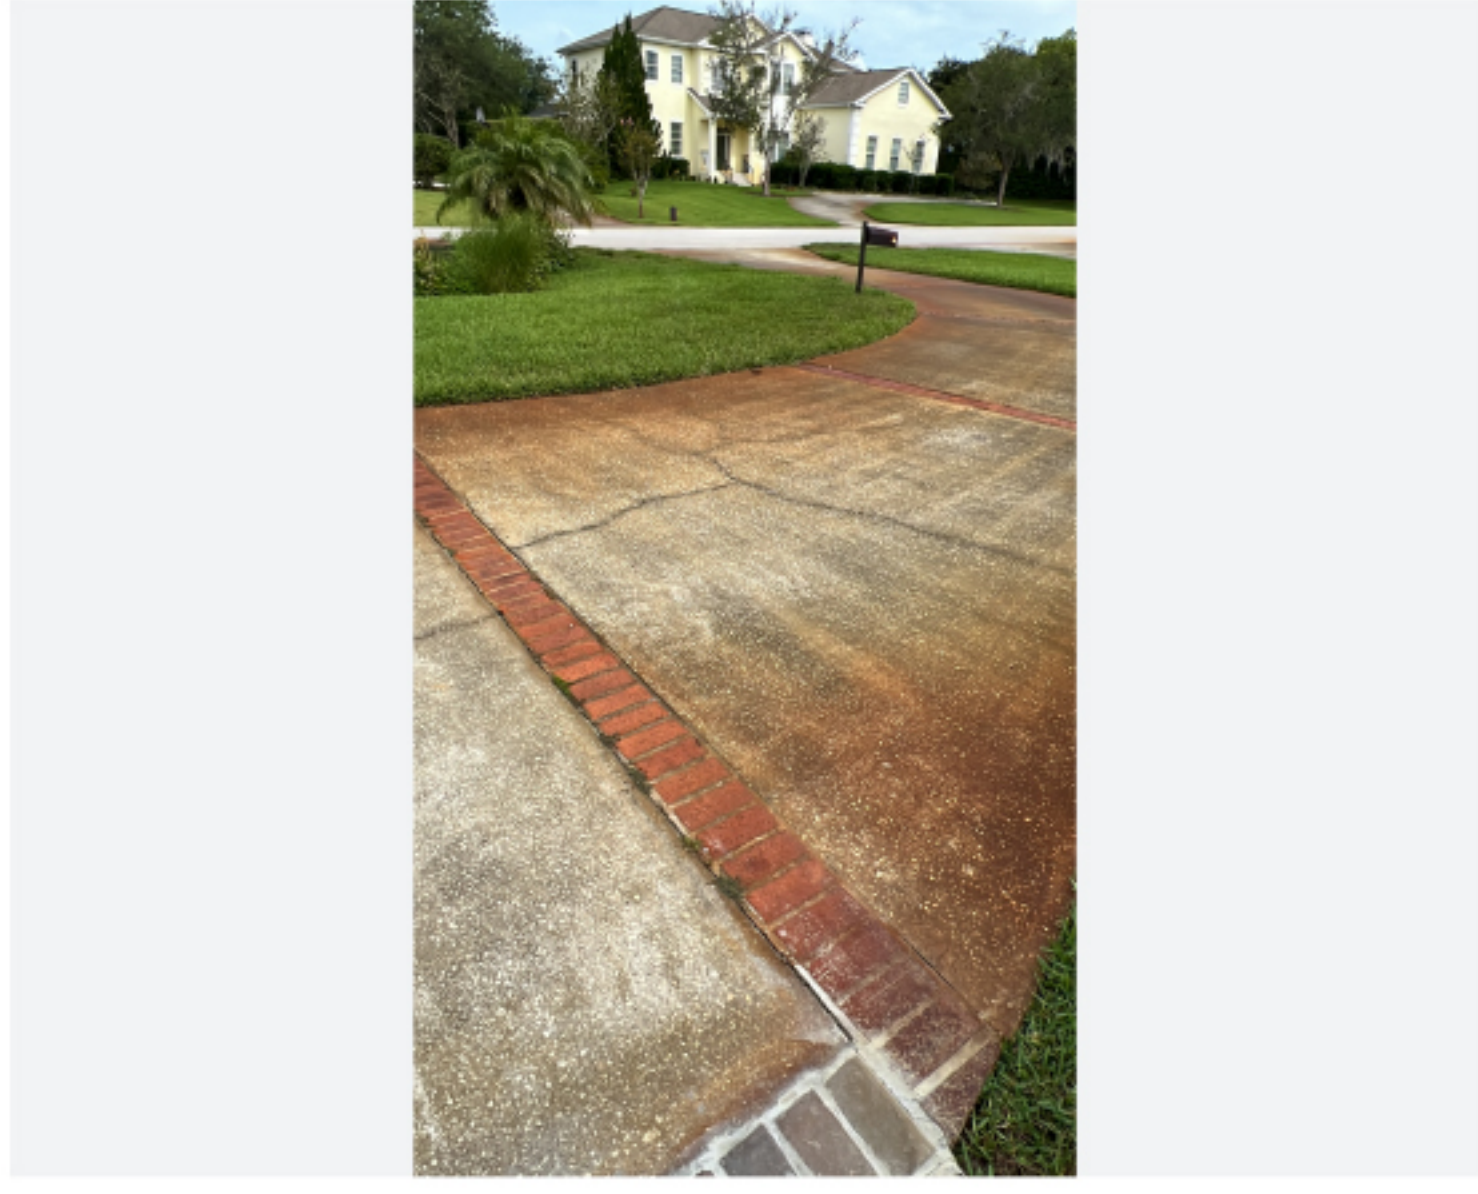
### 1.1 DRIVEWAY

- Typical cracking noted

Requires Attention

- Common cracks and stains present  
Recommend sealing crack(s) and resurfacing as needed

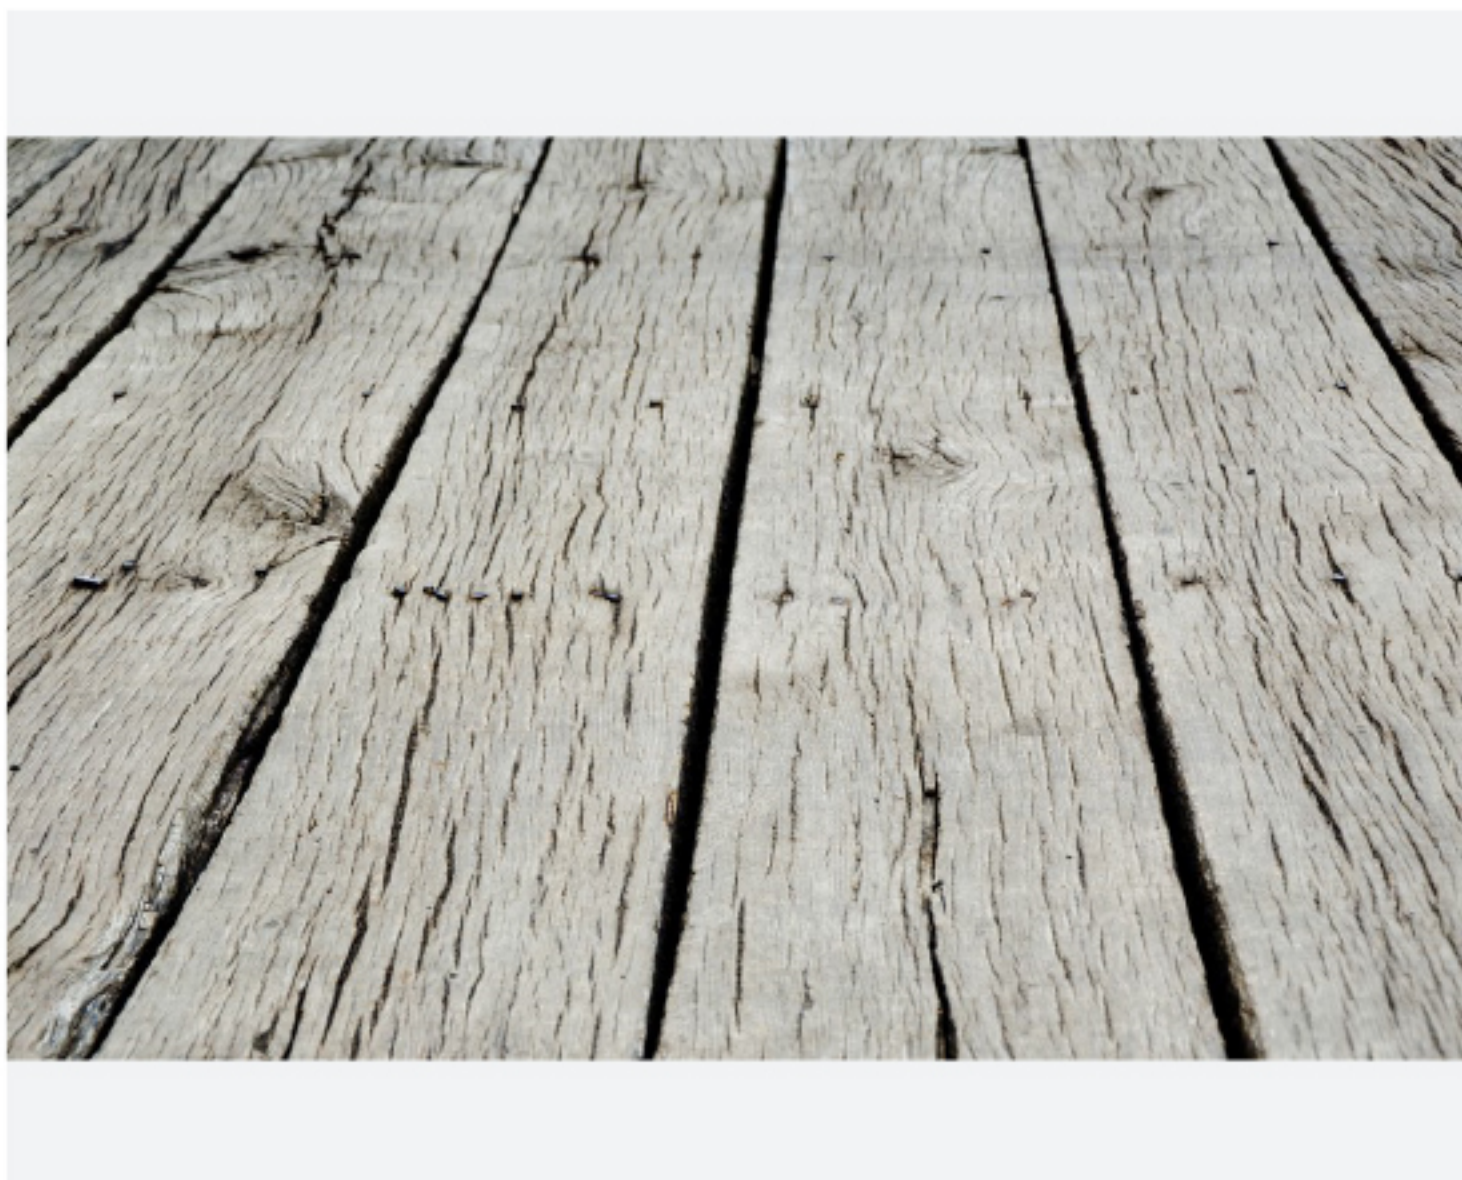
## 1.6 DECK/BALCONY

- **Moisture damage**  
Significant moisture damage and wood rot was noted at the deck. Recommend evaluation and repair by a licensed contractor or deck specialist.

Safety

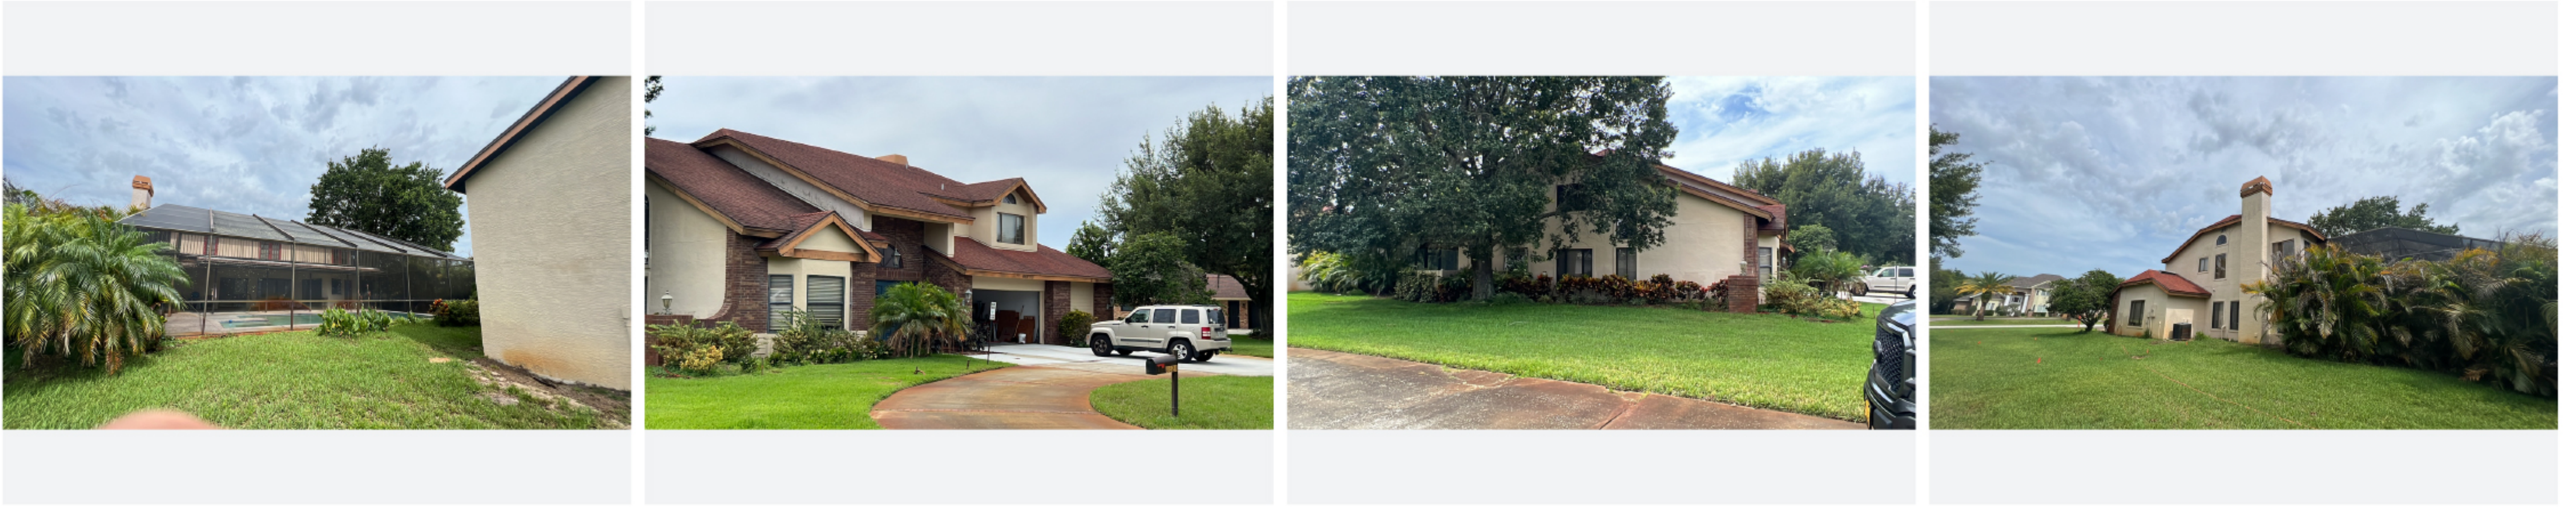
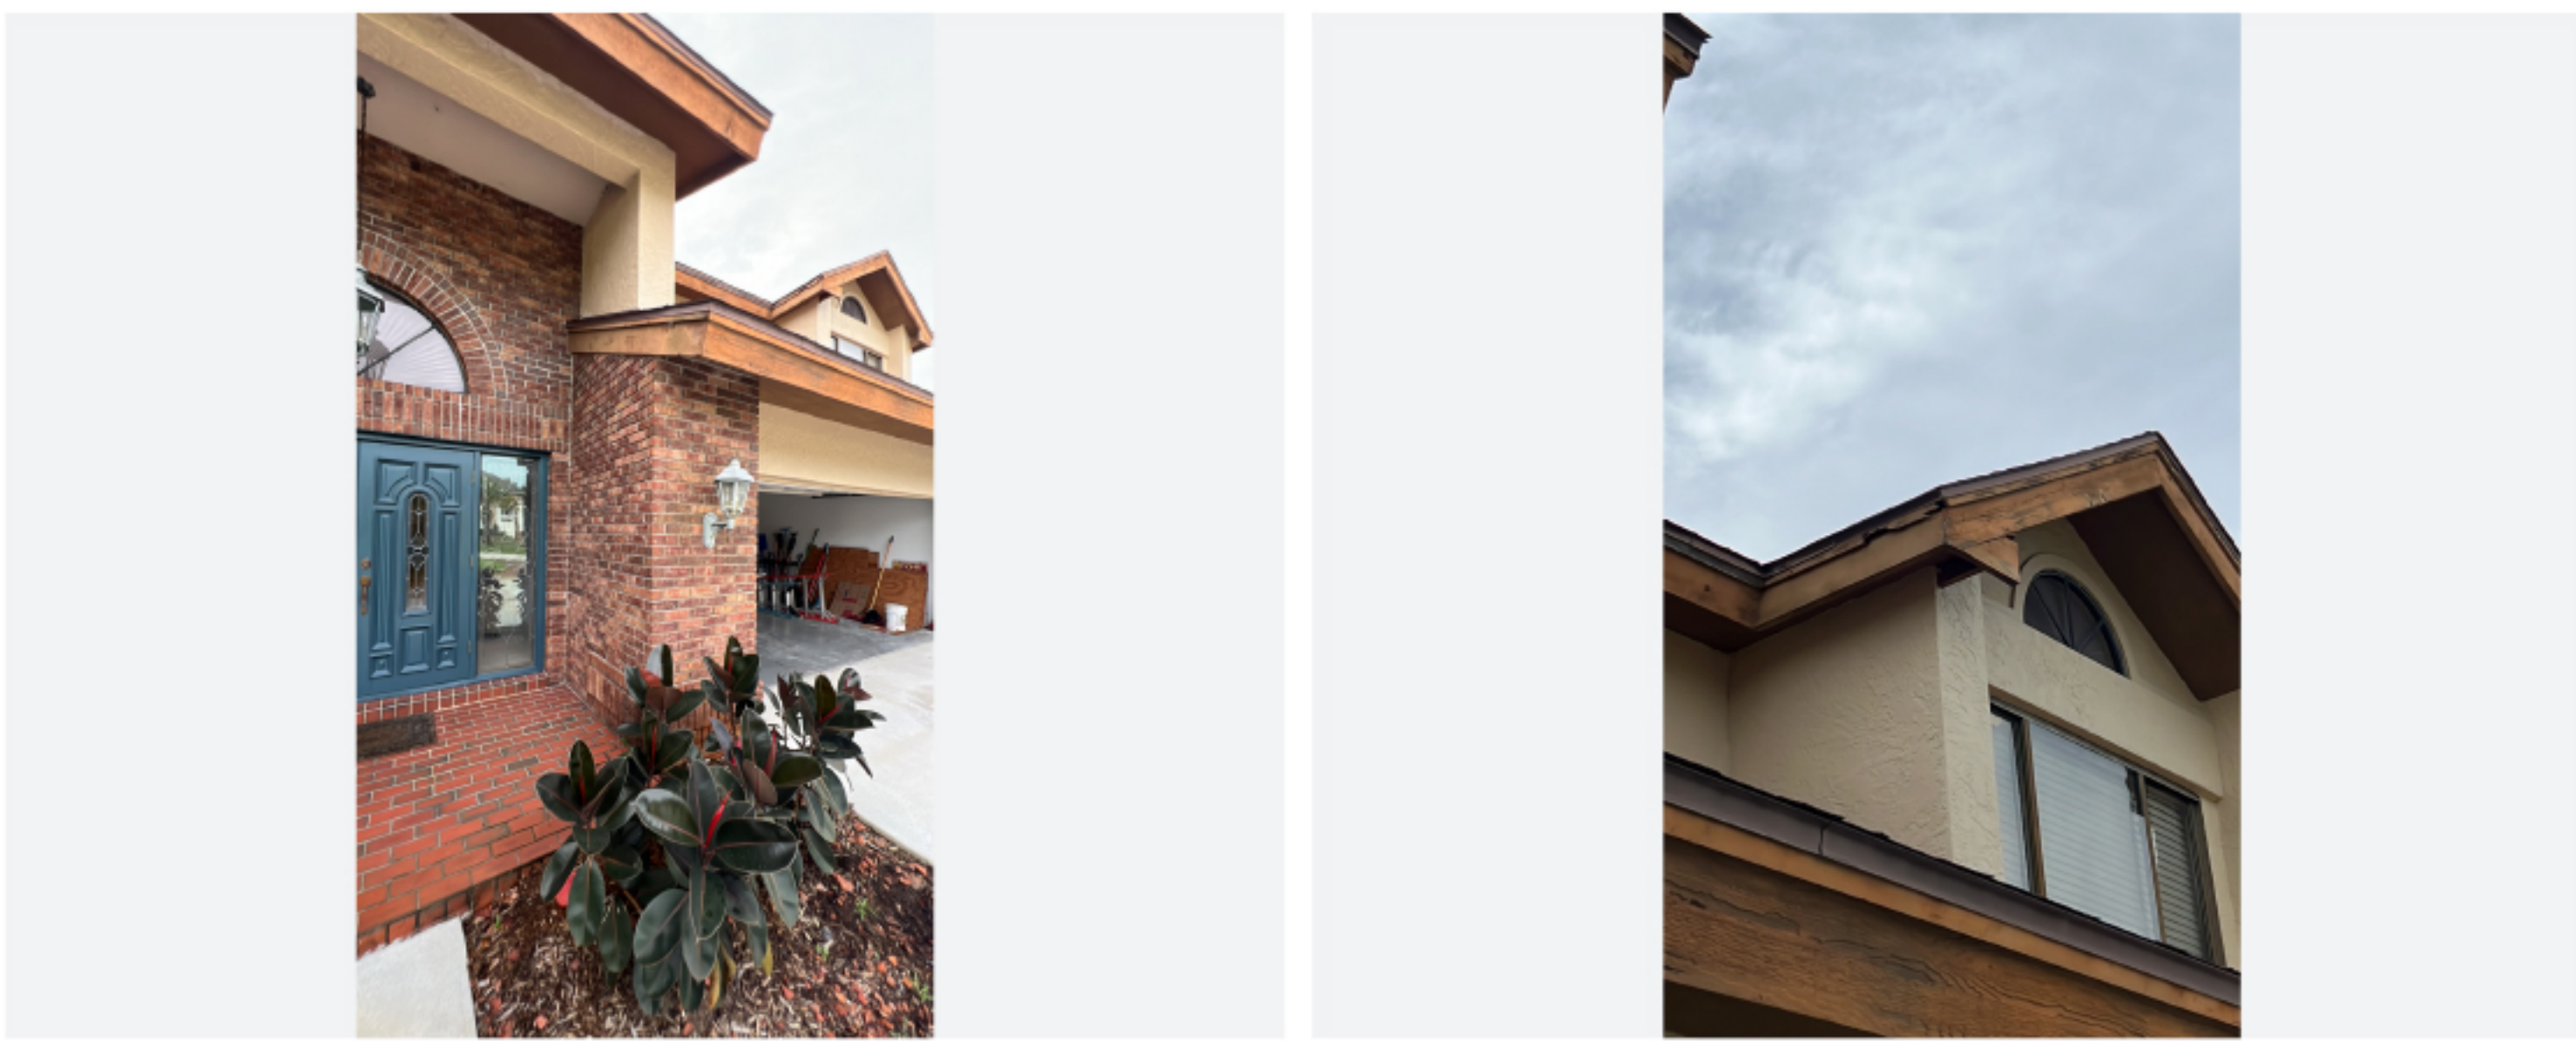
### 2.1 TYPE

- **Water damaged/deteriorated trim**  
Water damage was noted at several portions of the exterior fascia trim. Recommend repair/replacement by a licensed contractor.

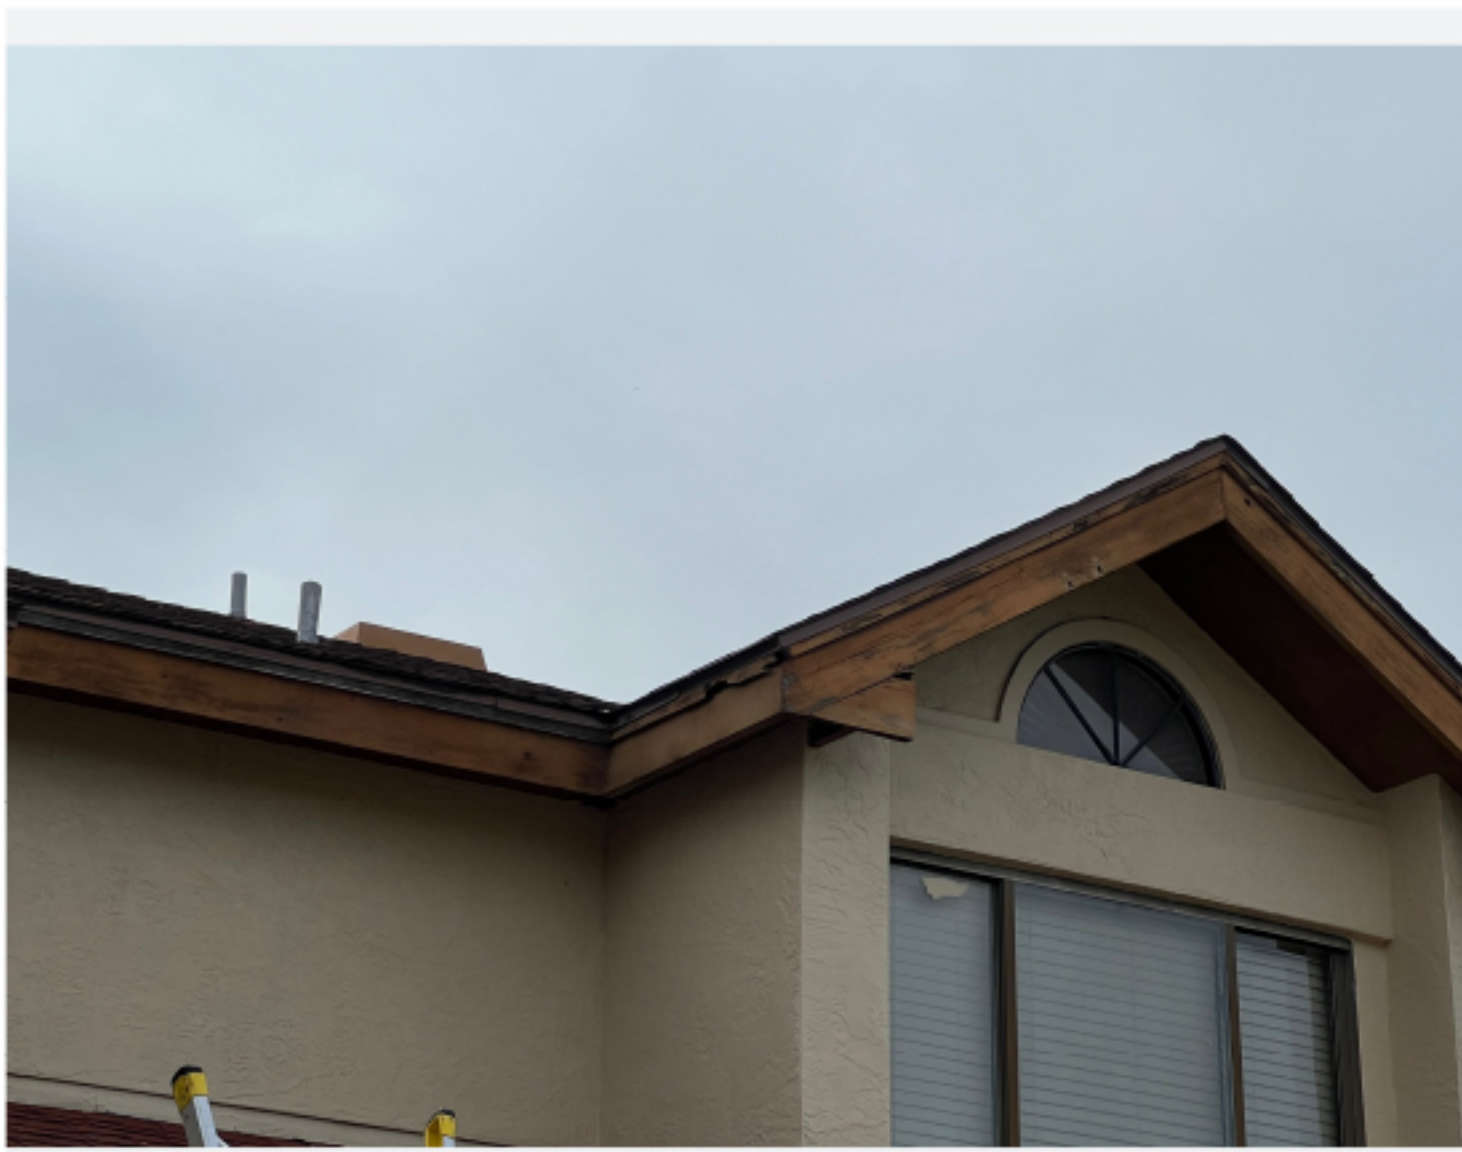
**2.2 SOFFITS/FASCIA**

- Wood rot was noted at portions of the fascia trim. See a licensed contractor for evaluation and repair/replacement as needed.

Requires Attention

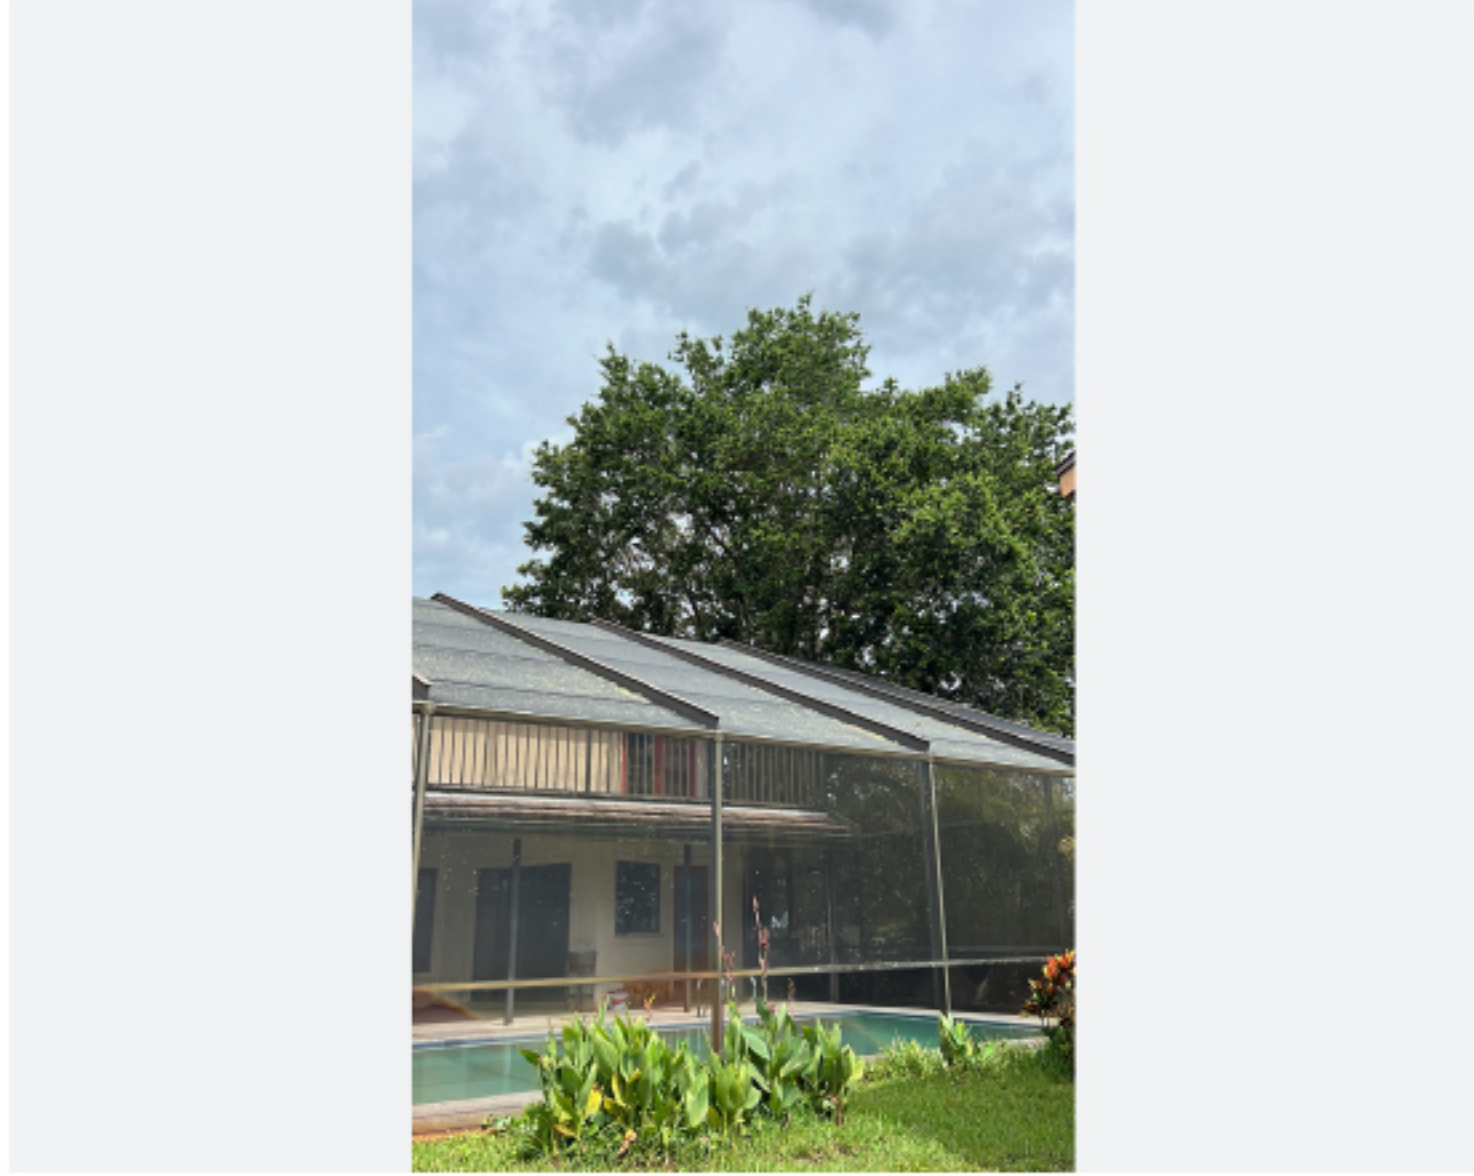
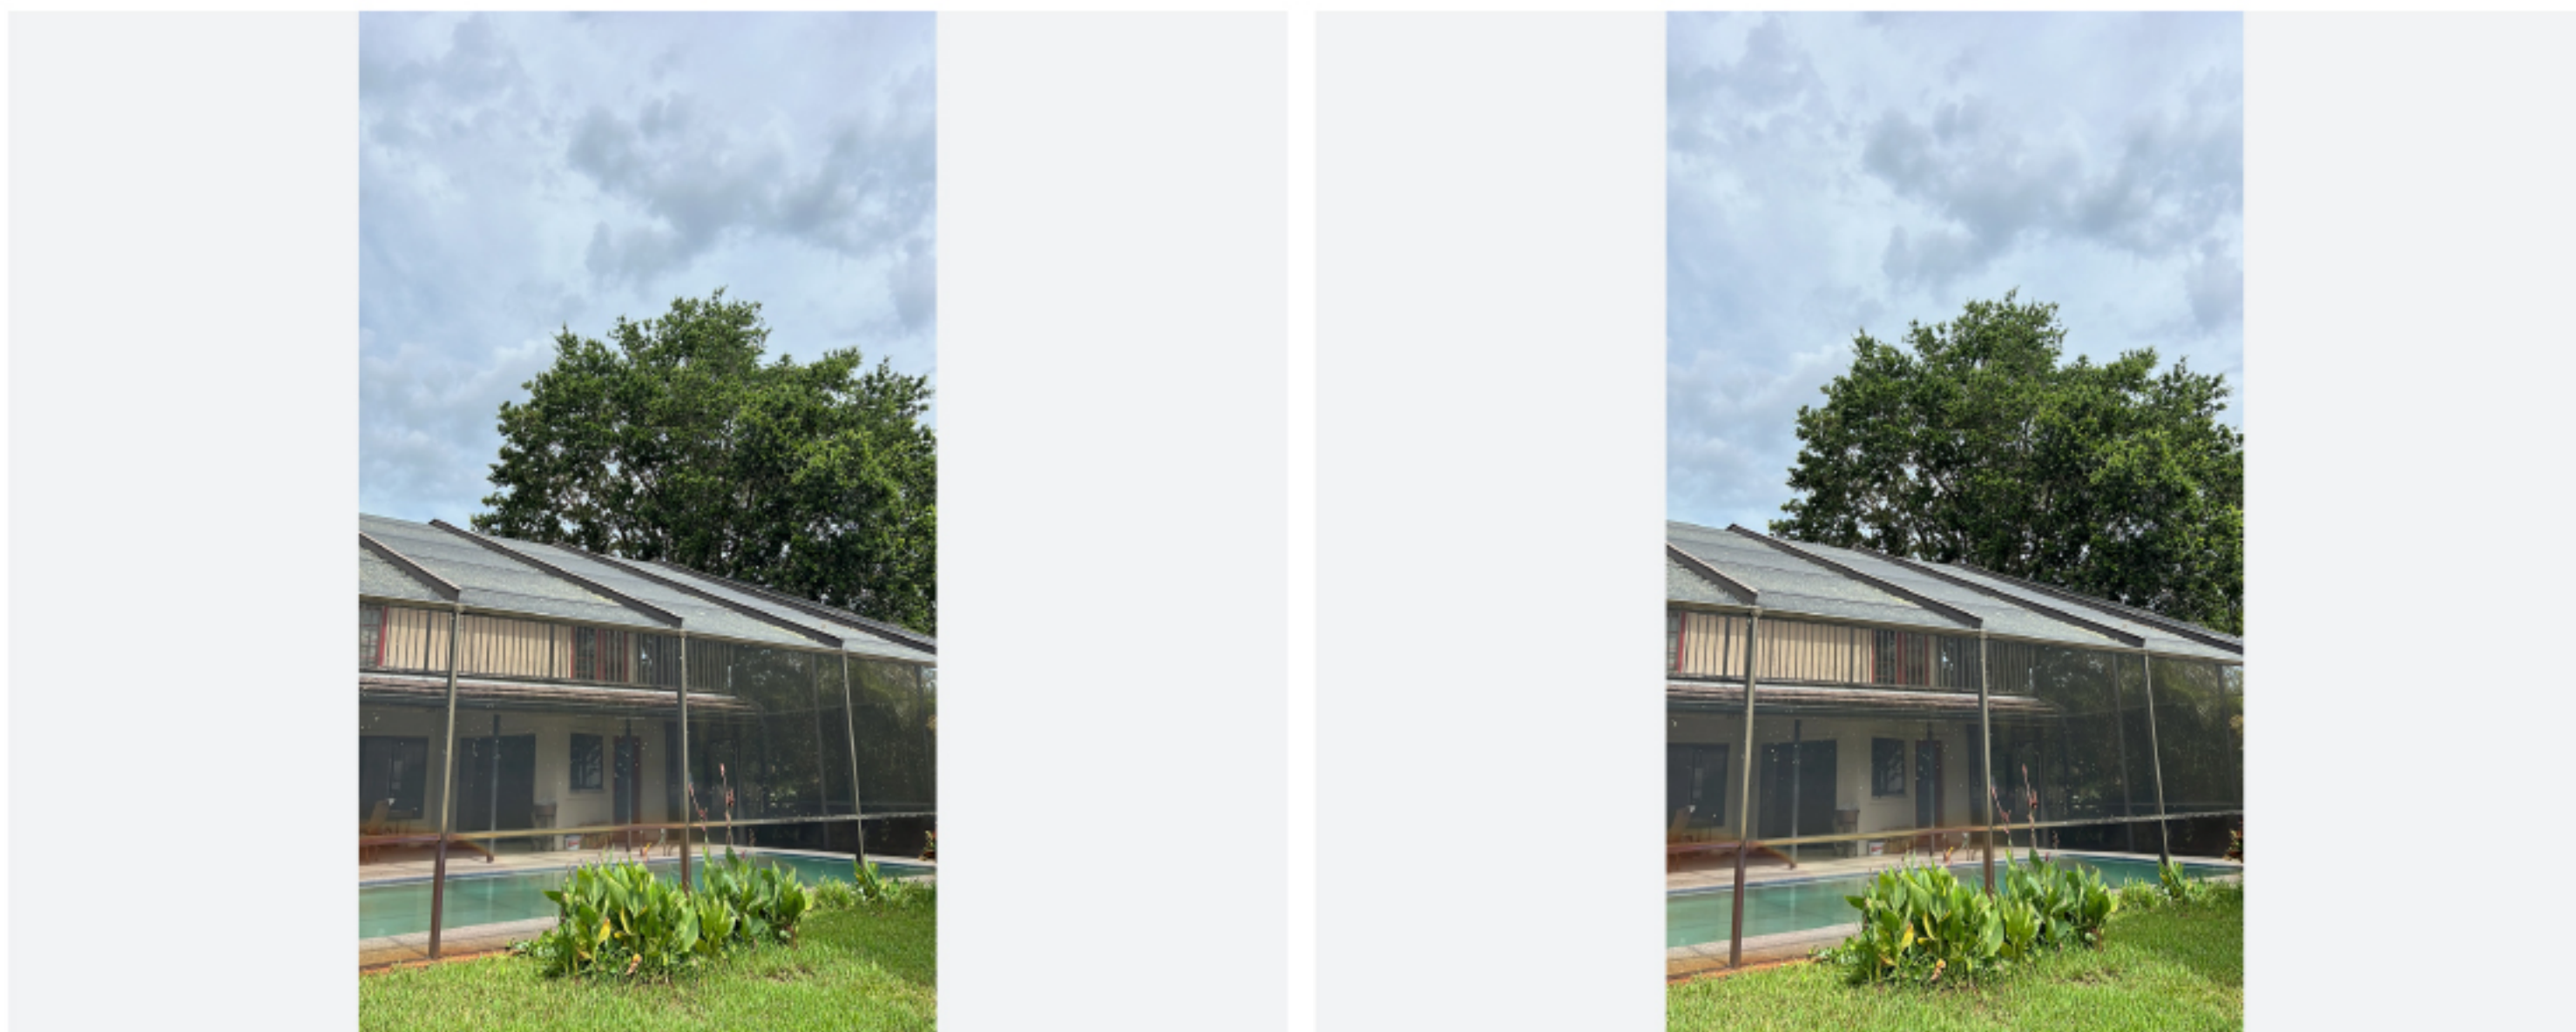
## 2.5 TREES AND VEGETATION

- **Overgrown/Overhanging Tree Limbs**  
Tree limbs are overhanging the roof and could damage roofing material. Recommend evaluation by an arborist.

Requires Attention

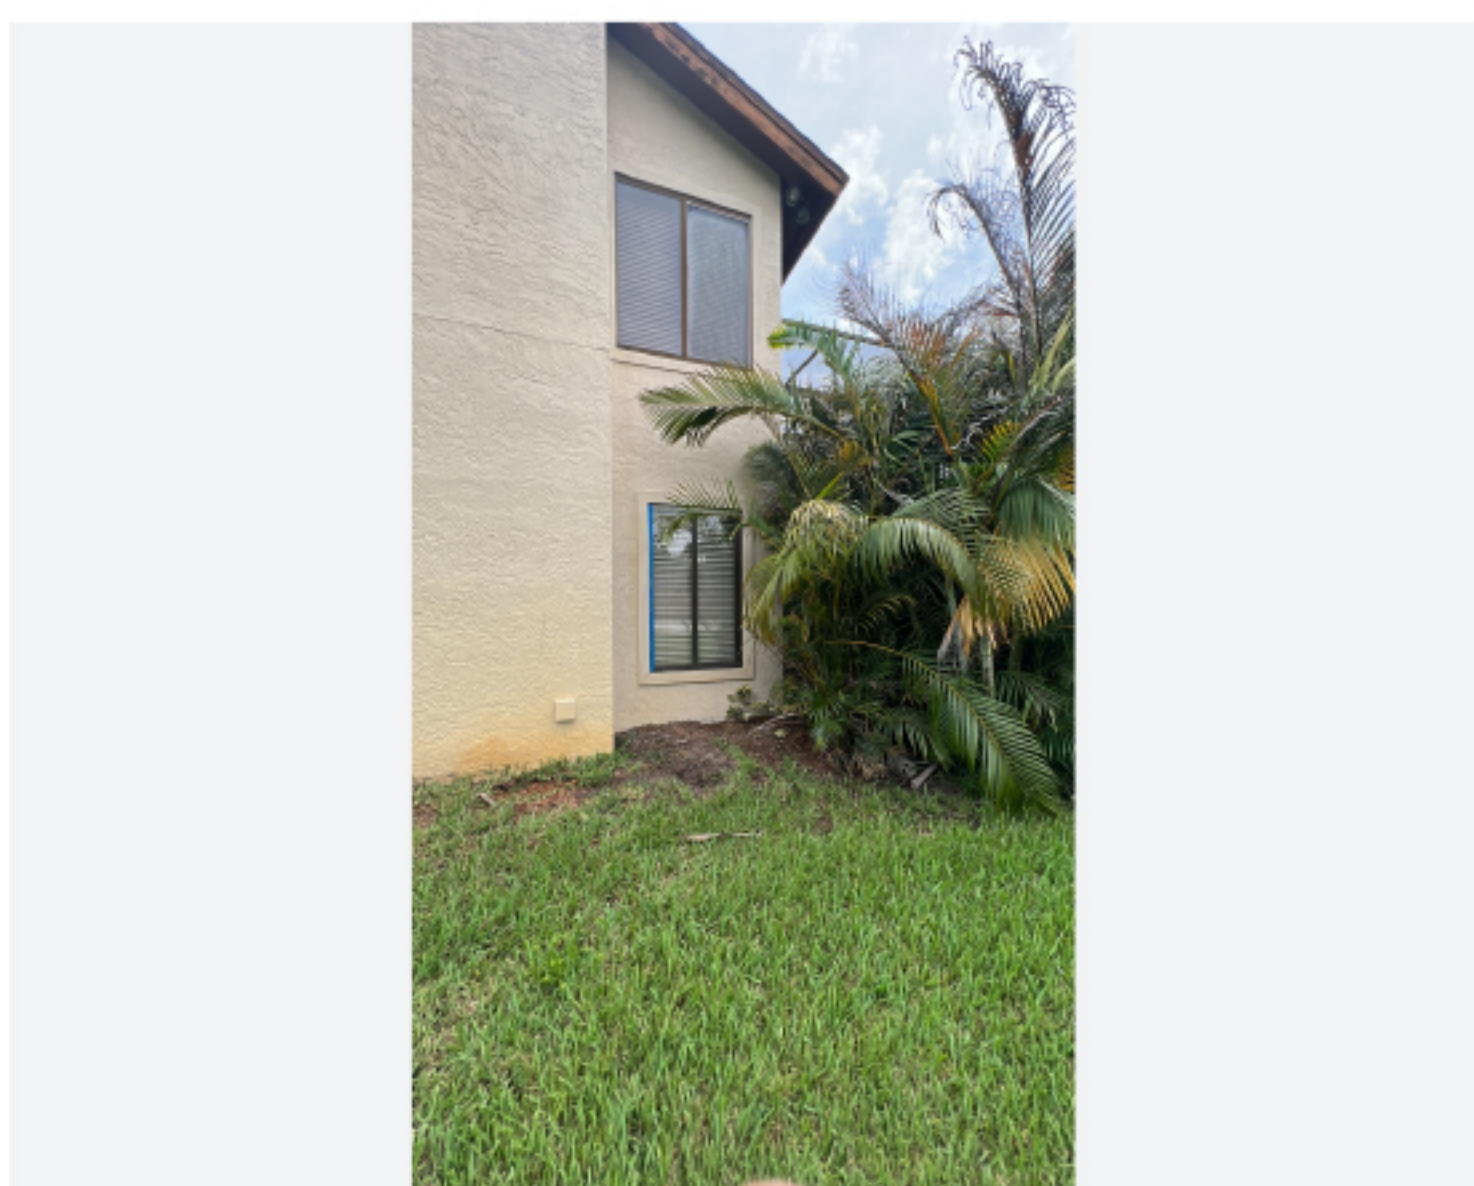
- **Vegetation Too Close to House**  
Plants and vegetation are in contact with the home. Recommend trimming 1-2 feet from exterior walls.

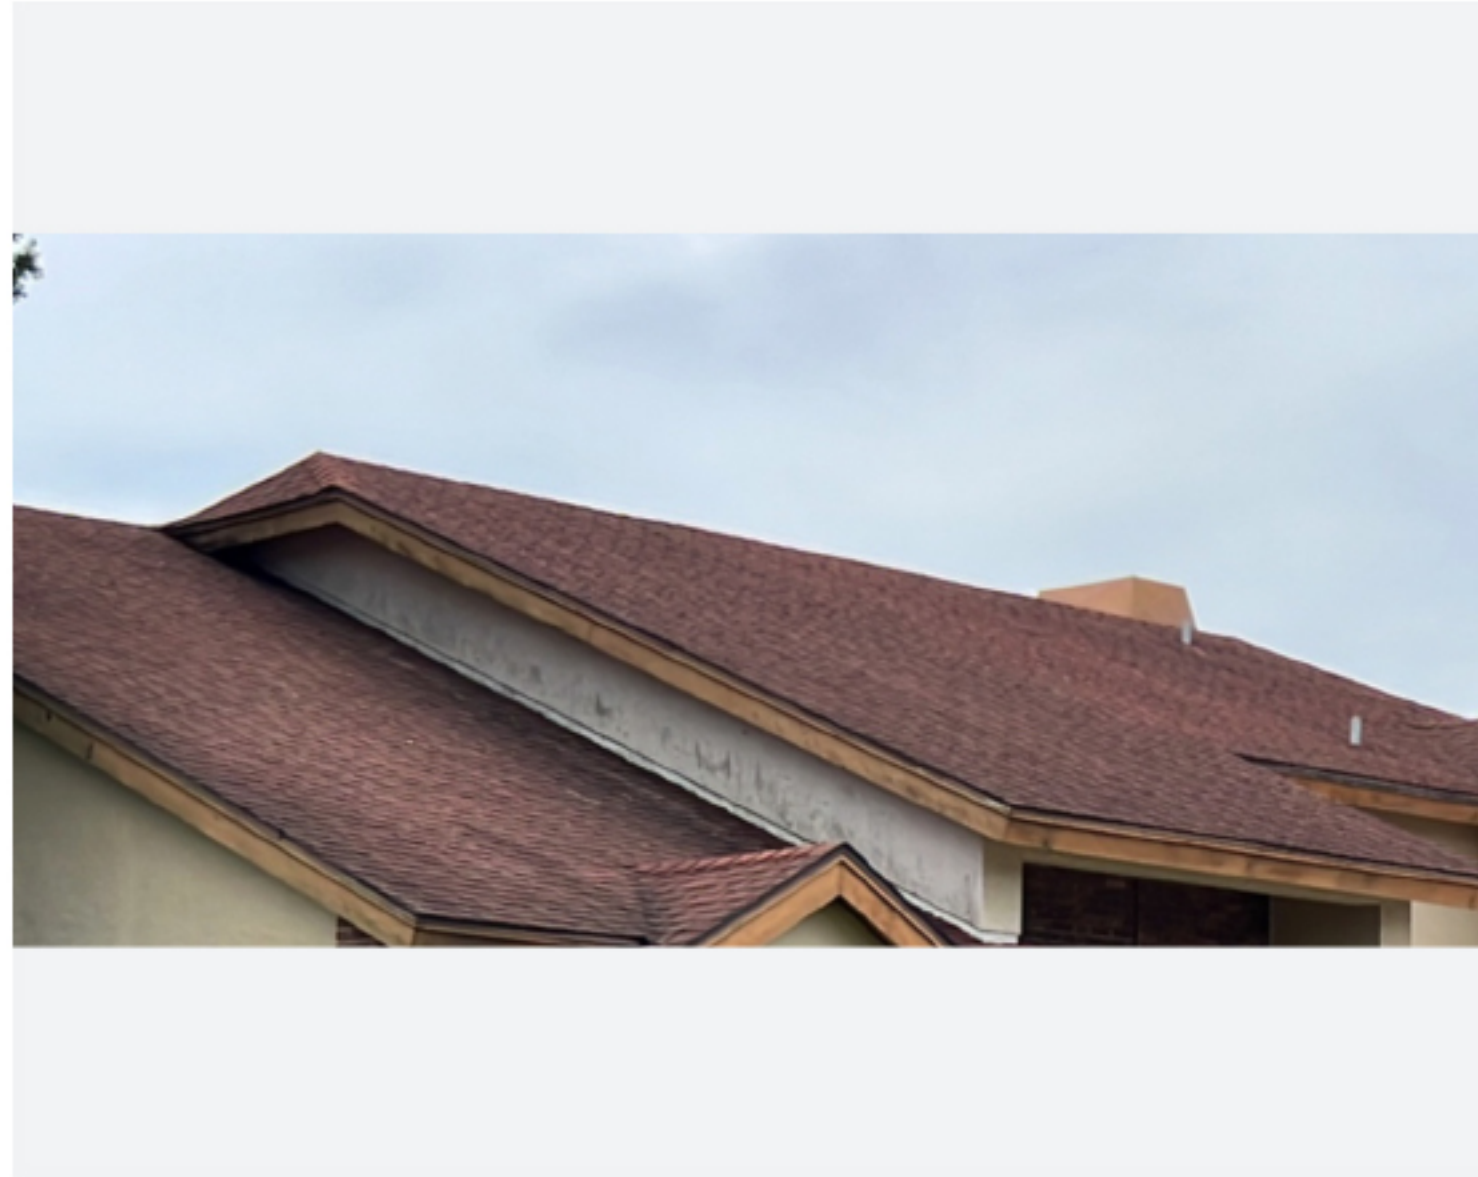
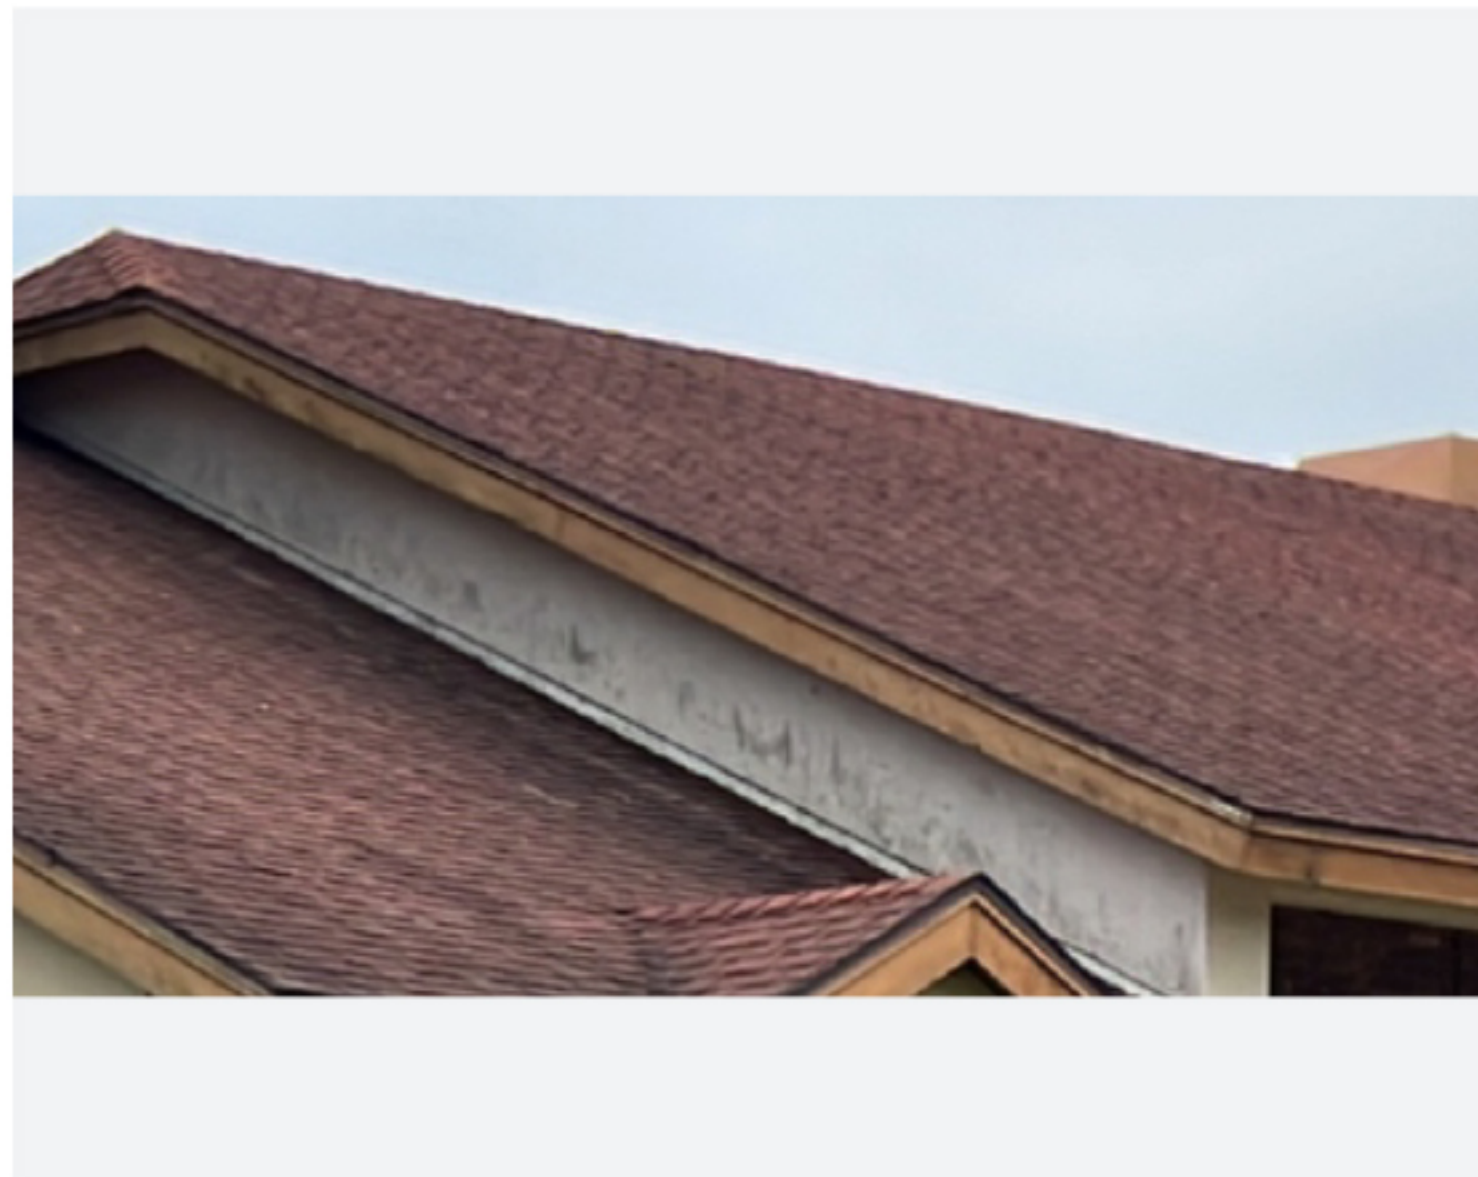
### 3.1 TYPE

- **Roof at/near end of useful life**

The roof shows advanced signs of aging and is within 3-5 years of the end of its life expectancy. Recommend evaluation and saving for replacement by a licensed/qualified roofer.

Recommendation
