Jun 20th, 2023

1234 Skywalker Drive, Tampa, 34654

# Home Inspection Report

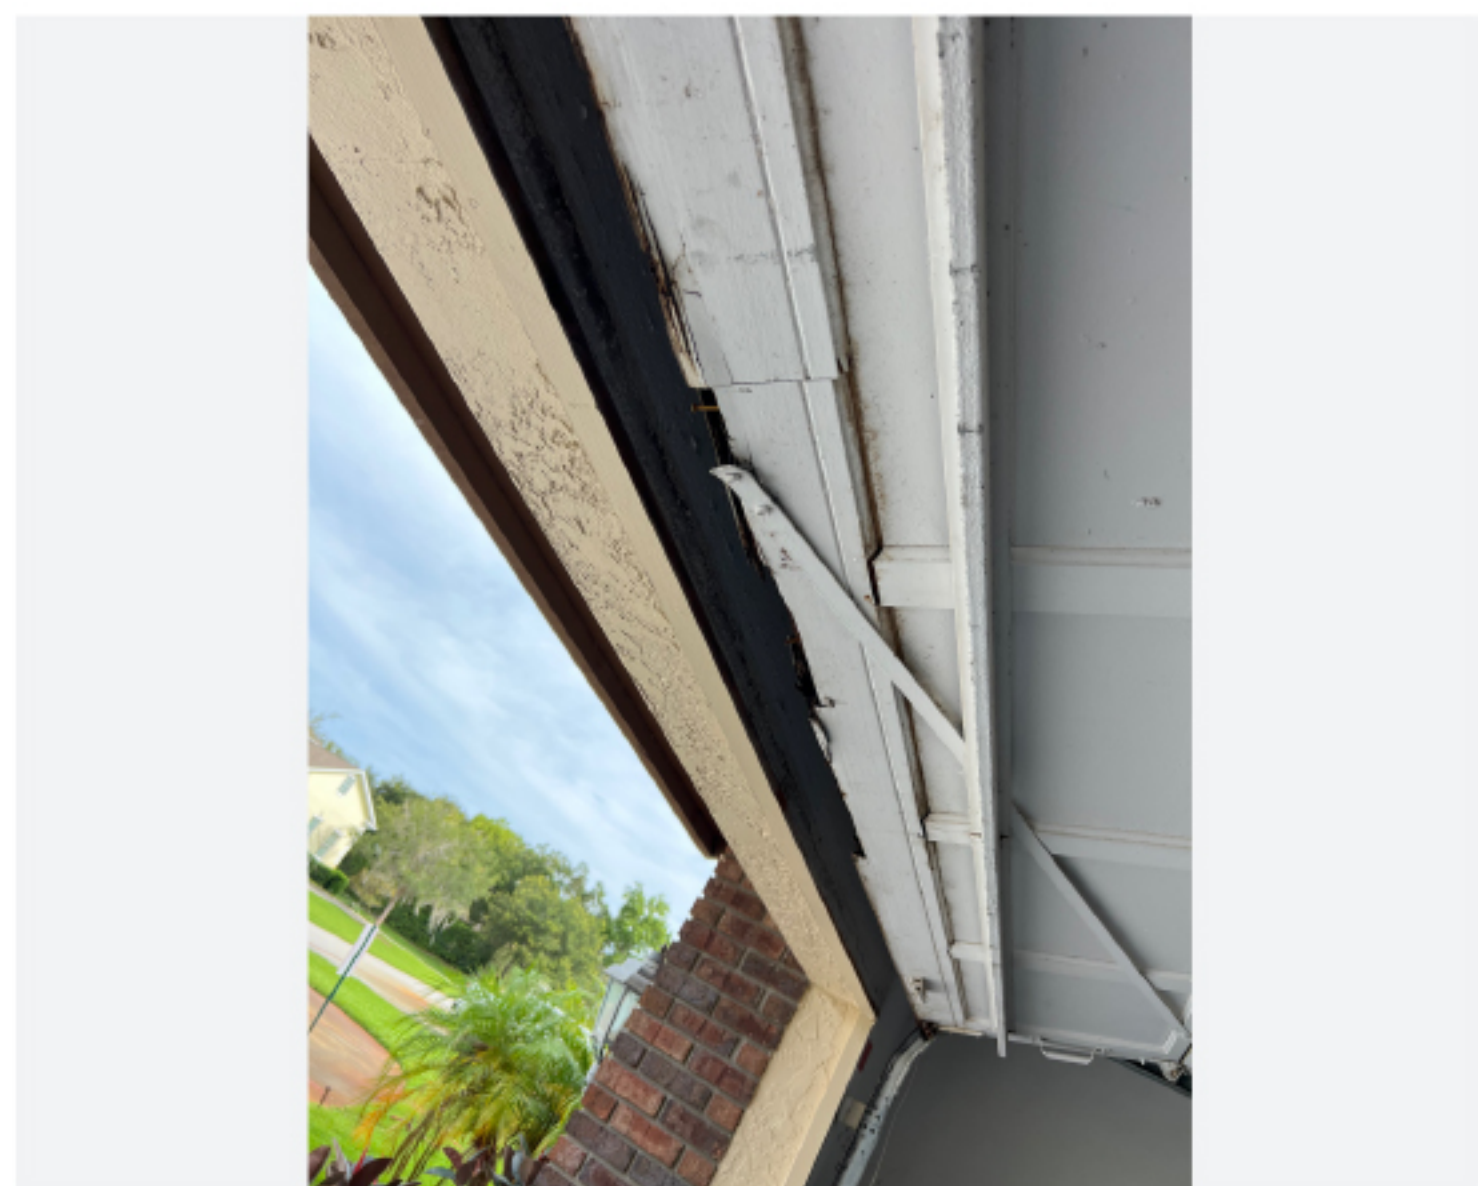
### 4.1 TYPE

- Water Damage to Base of Garage Door**  
 Water damage was noted to the base of the garage door. Recommend evaluation and repair by a licensed contractor or garage door specialist.

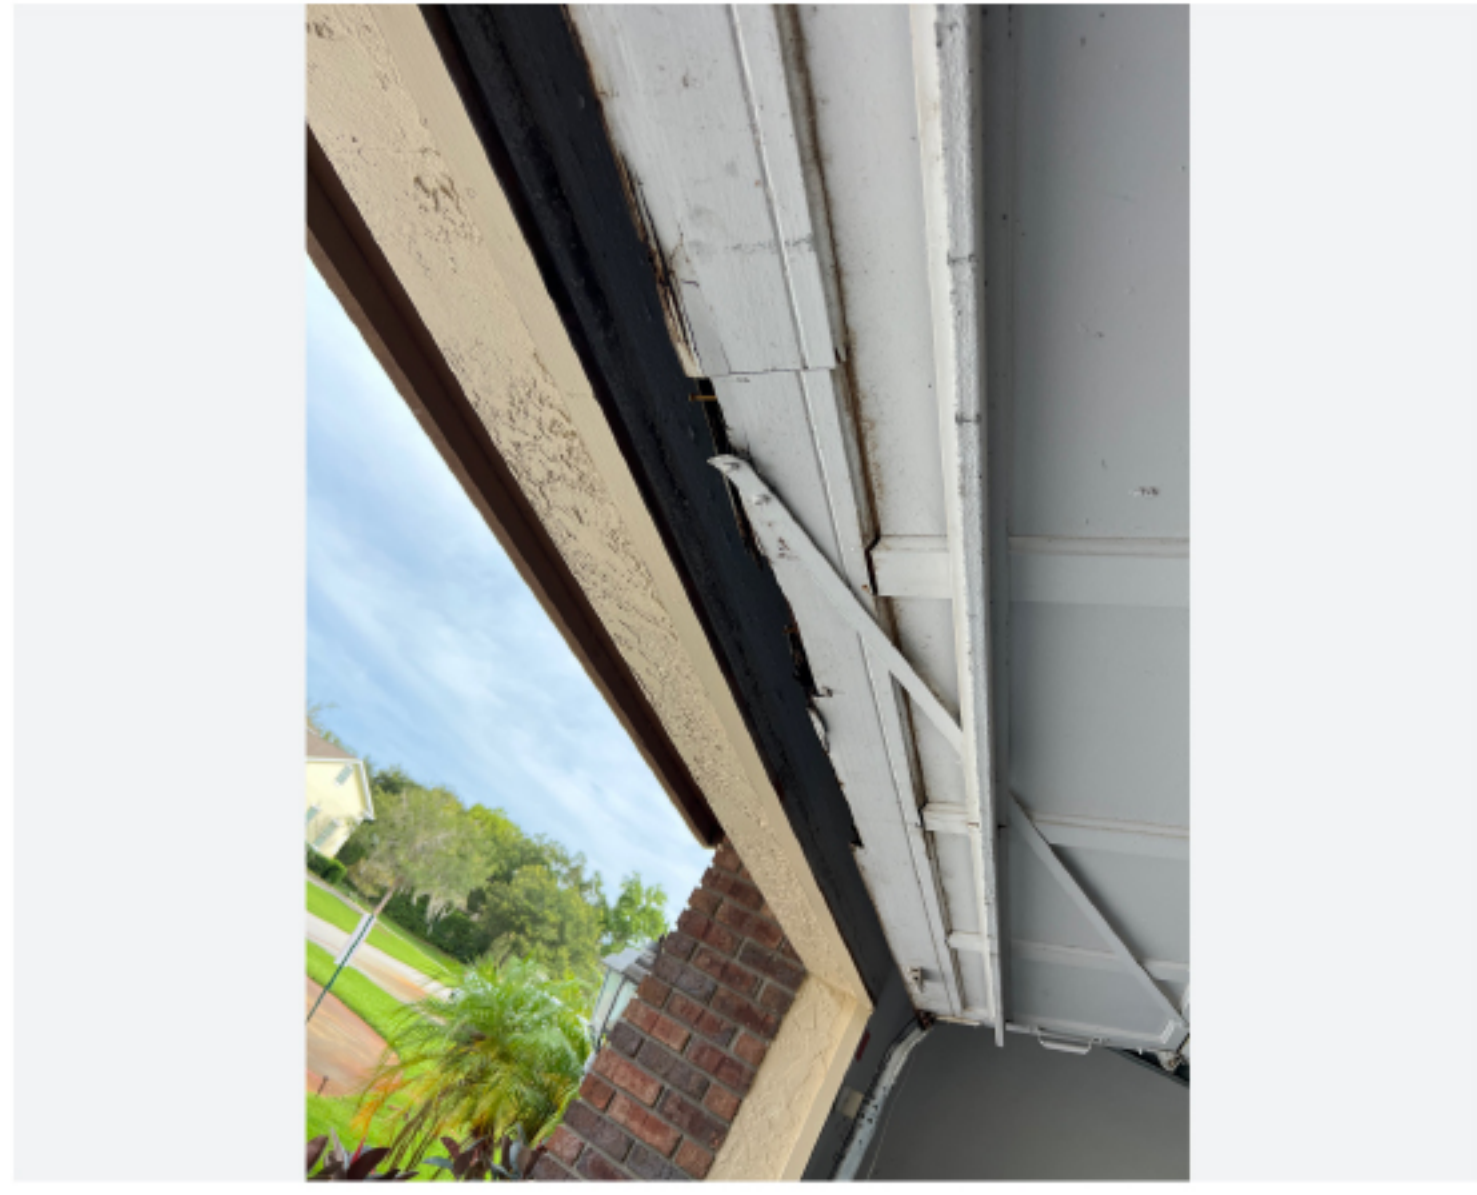
### 4.2 GARAGE DOORS

- Water Damage to Base of Garage Door**  
 Water damage was noted at the base of the garage door. Recommend evaluation and repair by a licensed contractor or garage door specialist.

Requires Attention

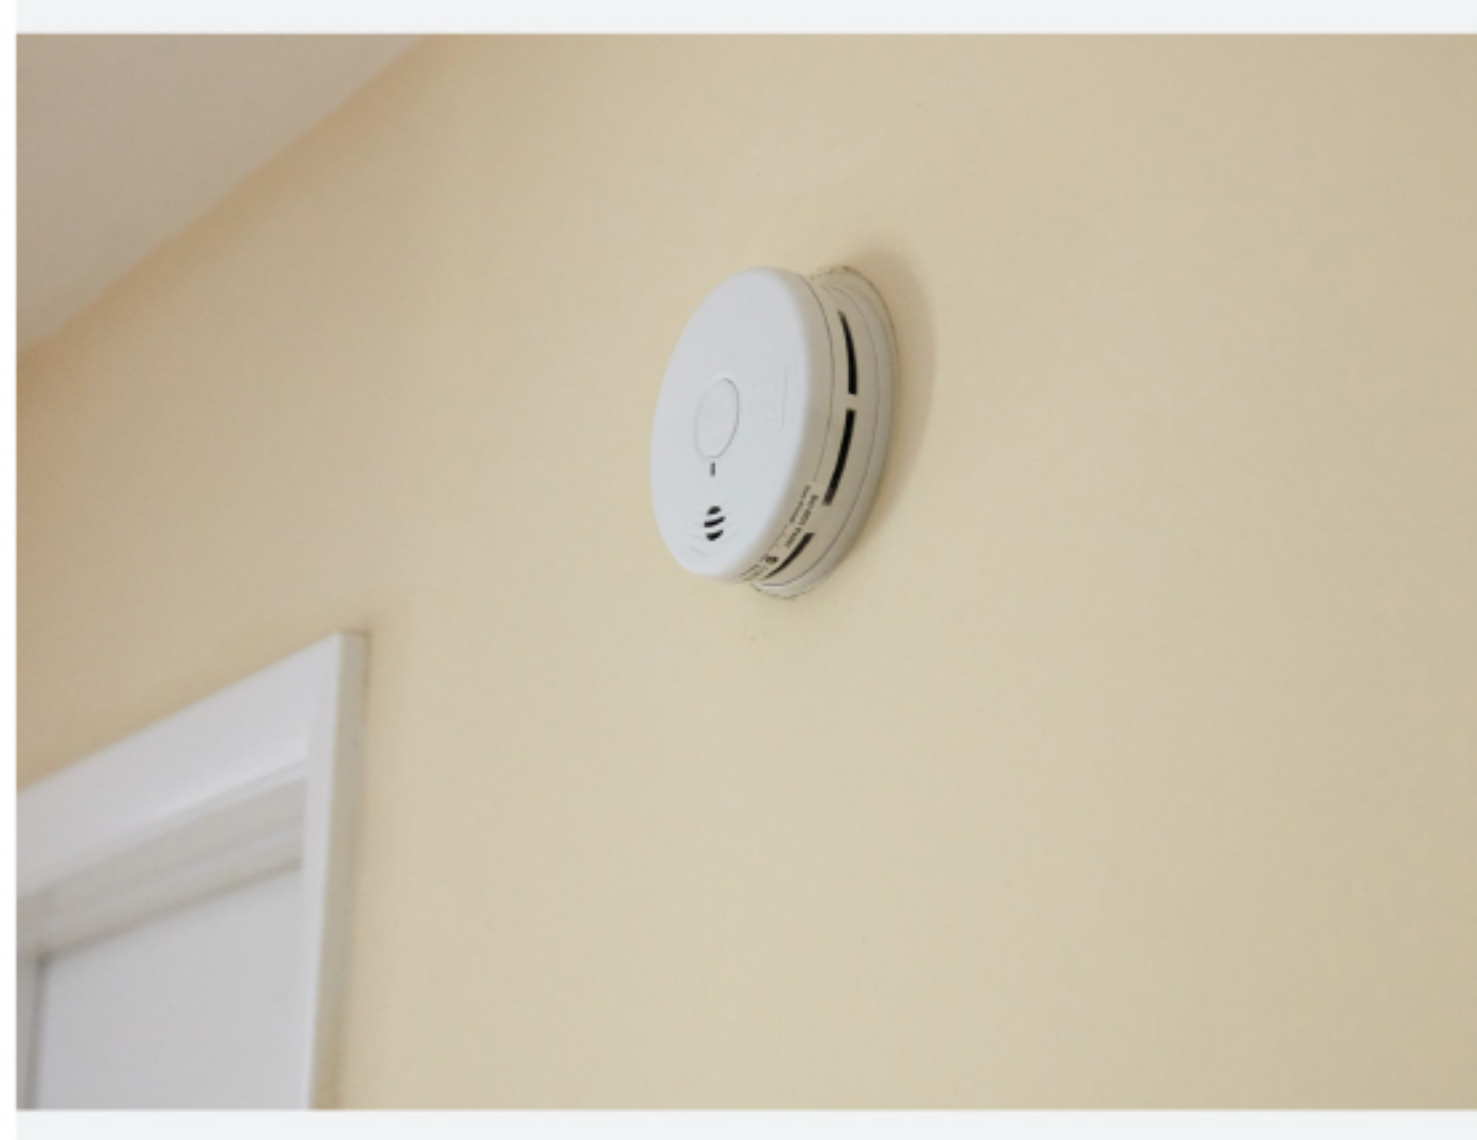
**Location -** 2nd Floor

- Missing/Low battery

Requires Attention

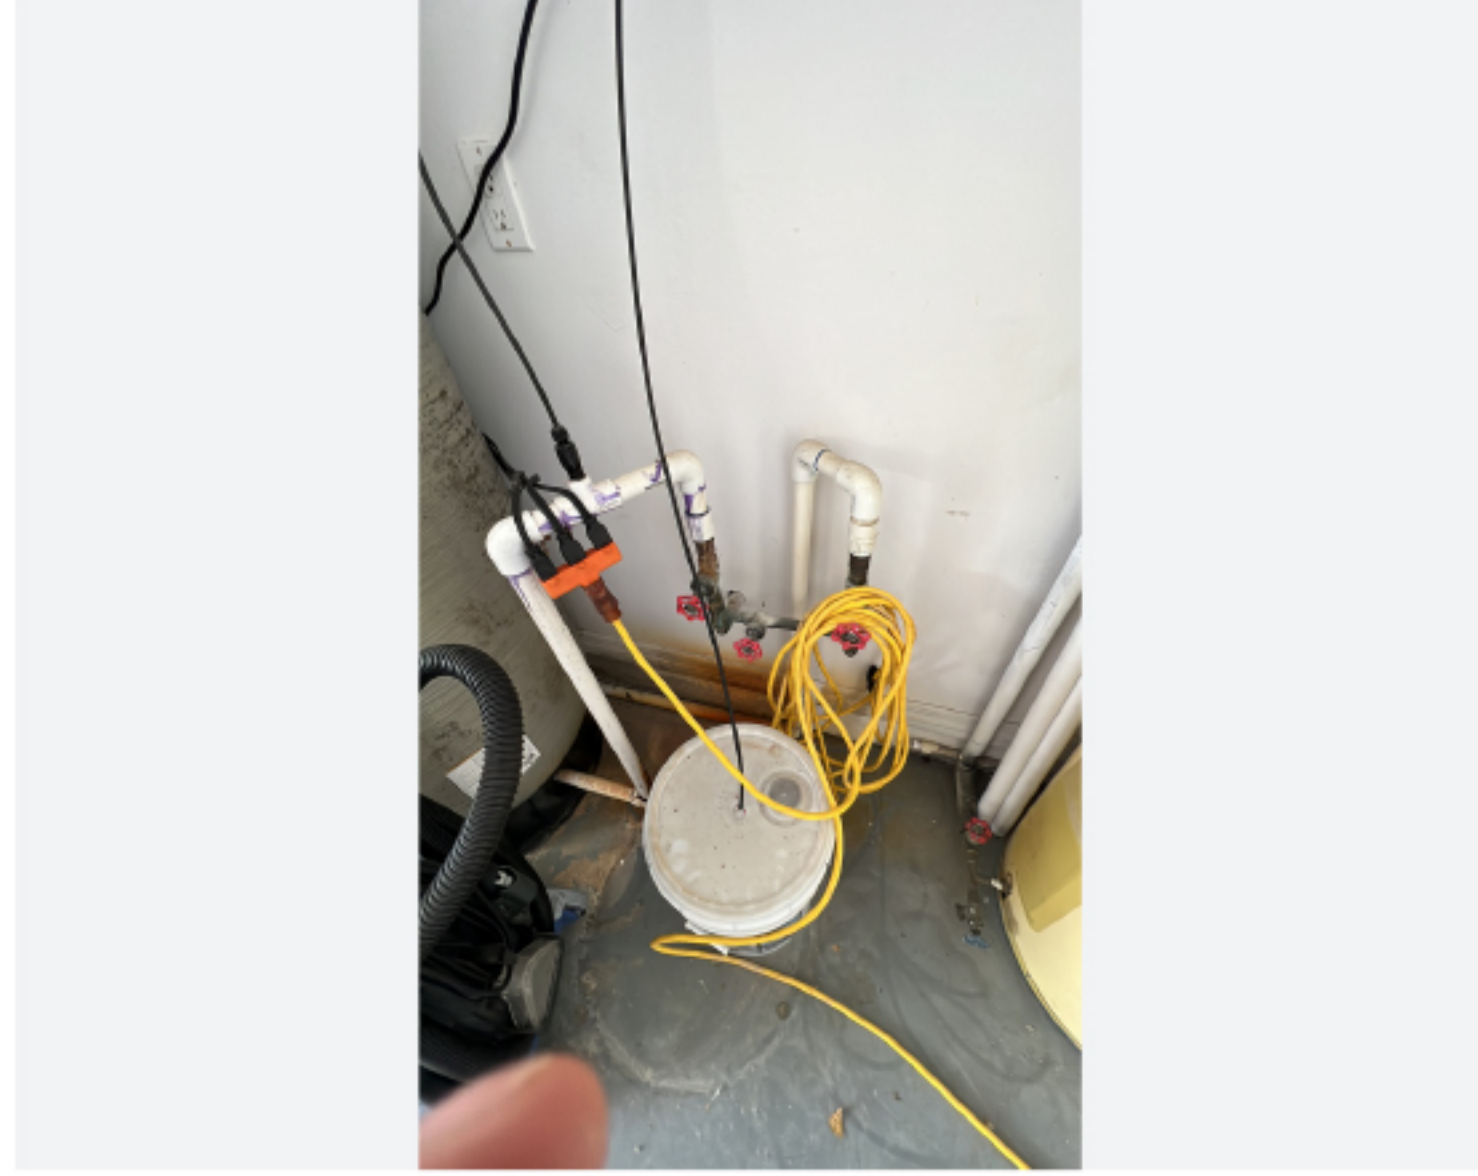
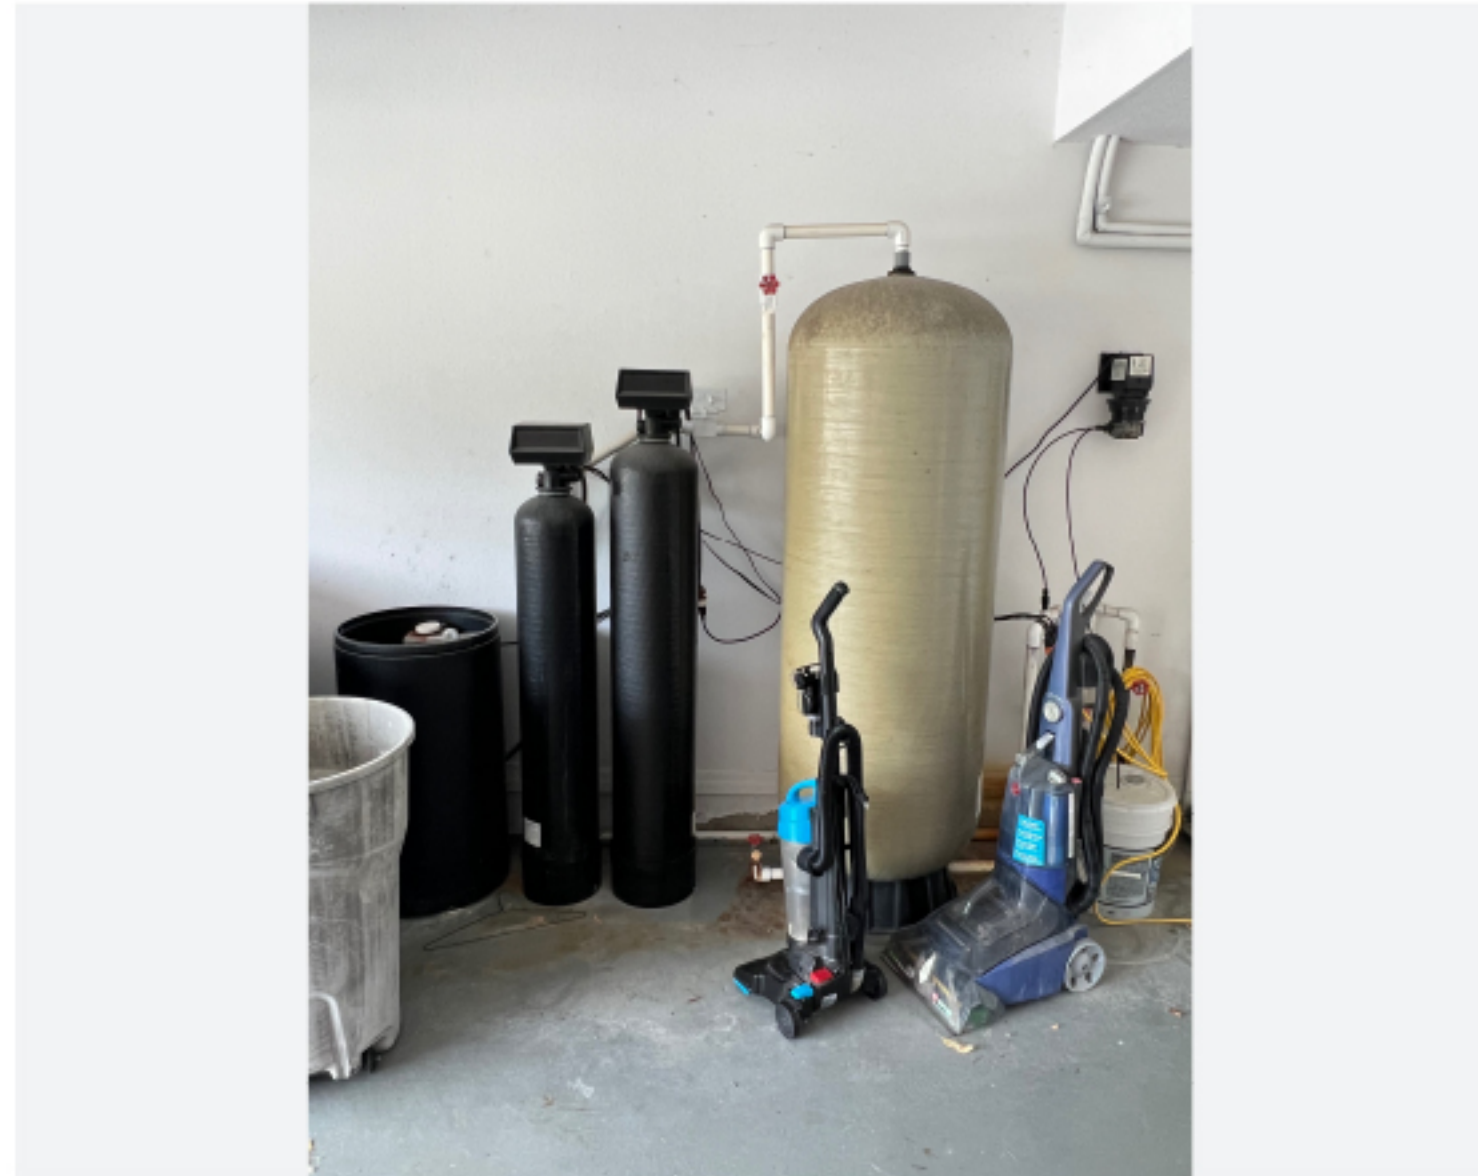
## 7.2 MAIN WATER SHUTOFF

- **Filtration System Not Inspected**  
Inspection of the water filtration system goes beyond the scope of the inspection. Recommend servicing as needed by a licensed plumber.

Maintenance

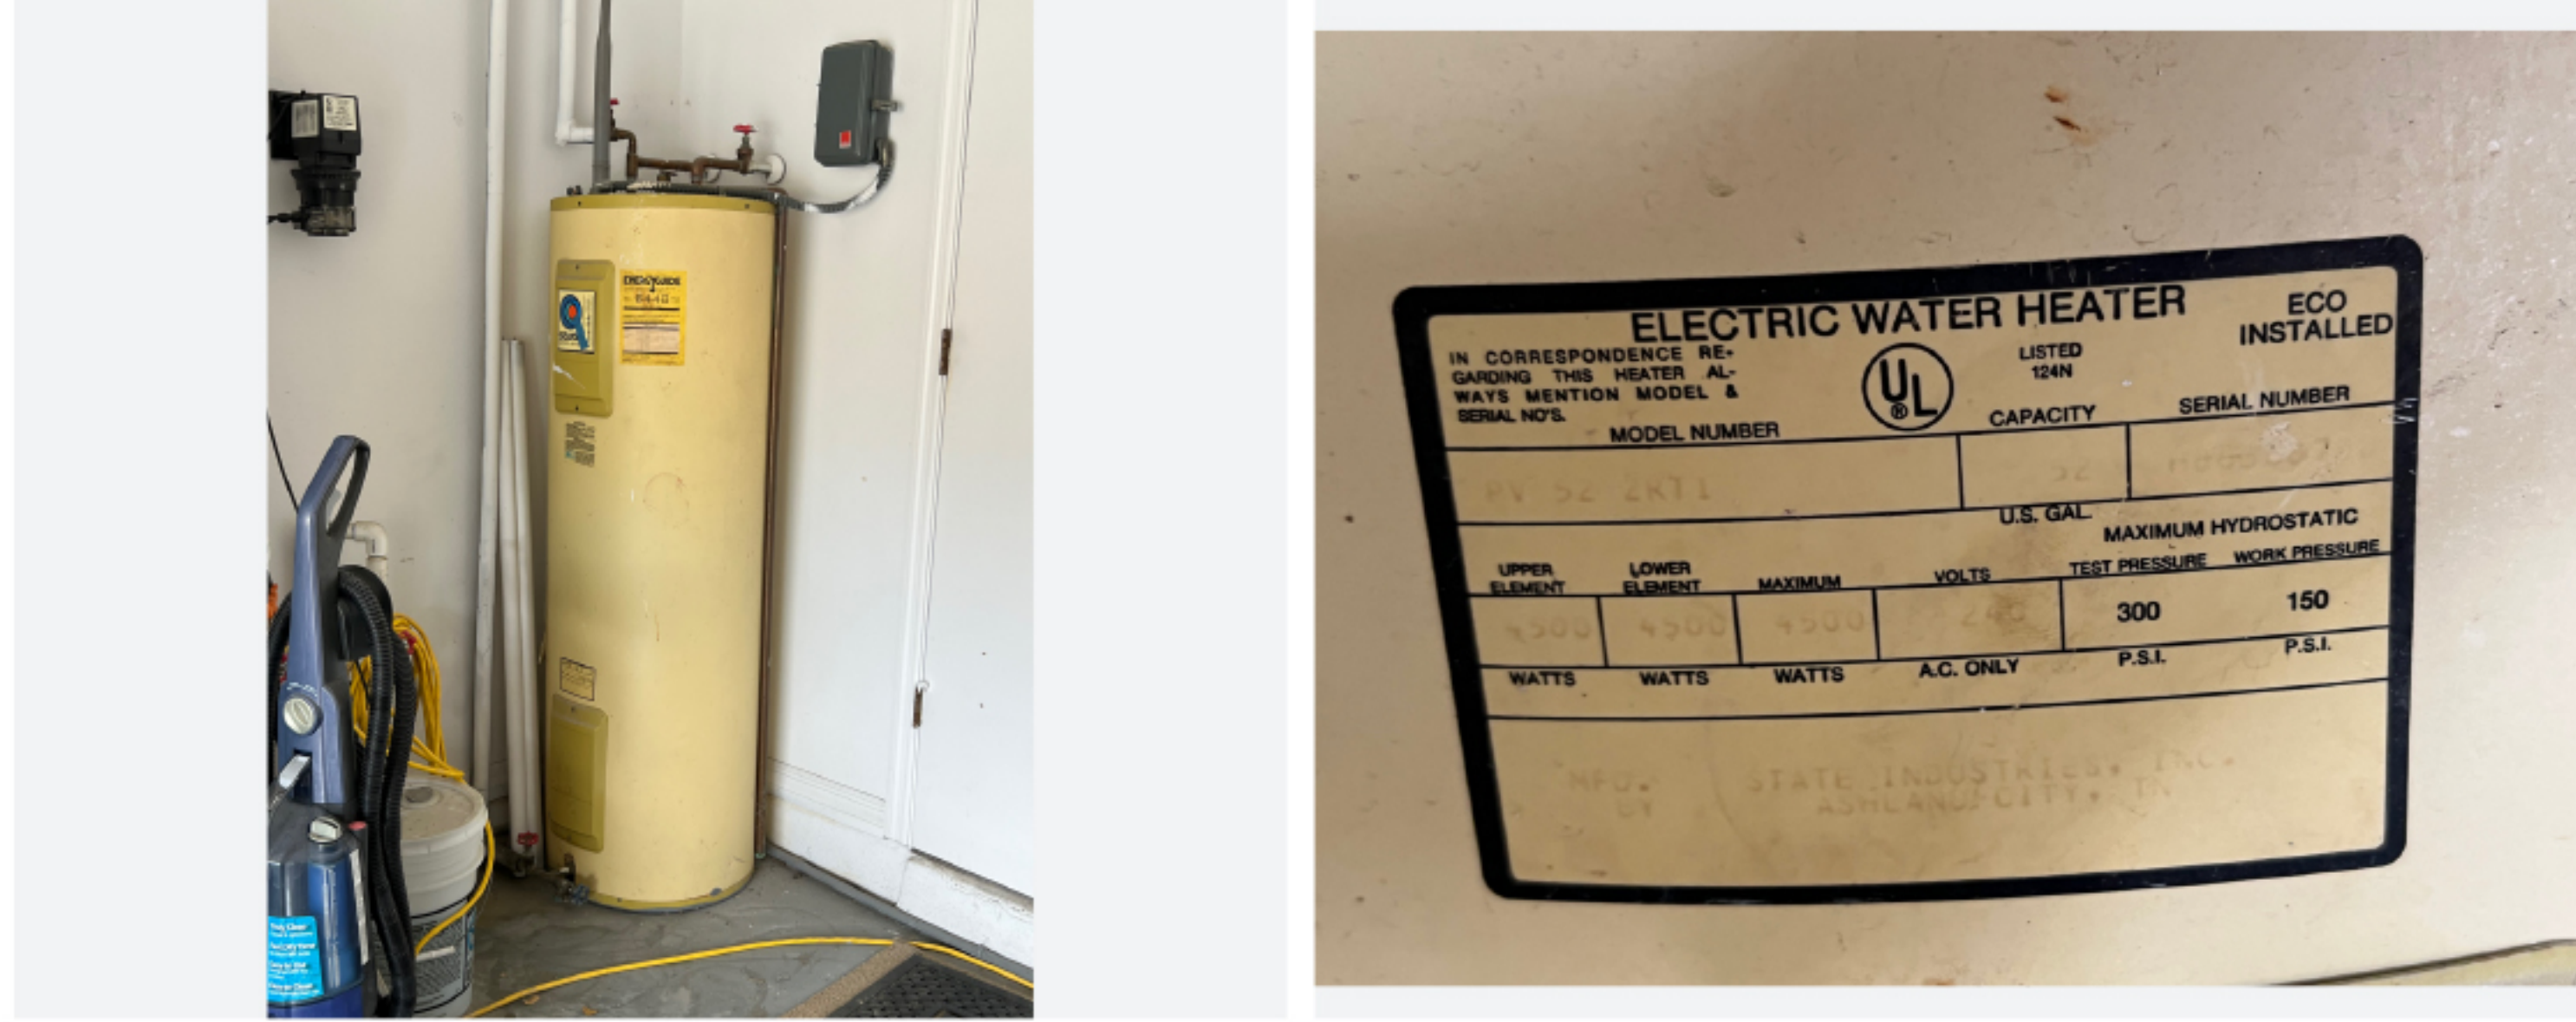
## 7.6 WATER HEATER

- Water heater has exceeded design life

**Requires Attention**

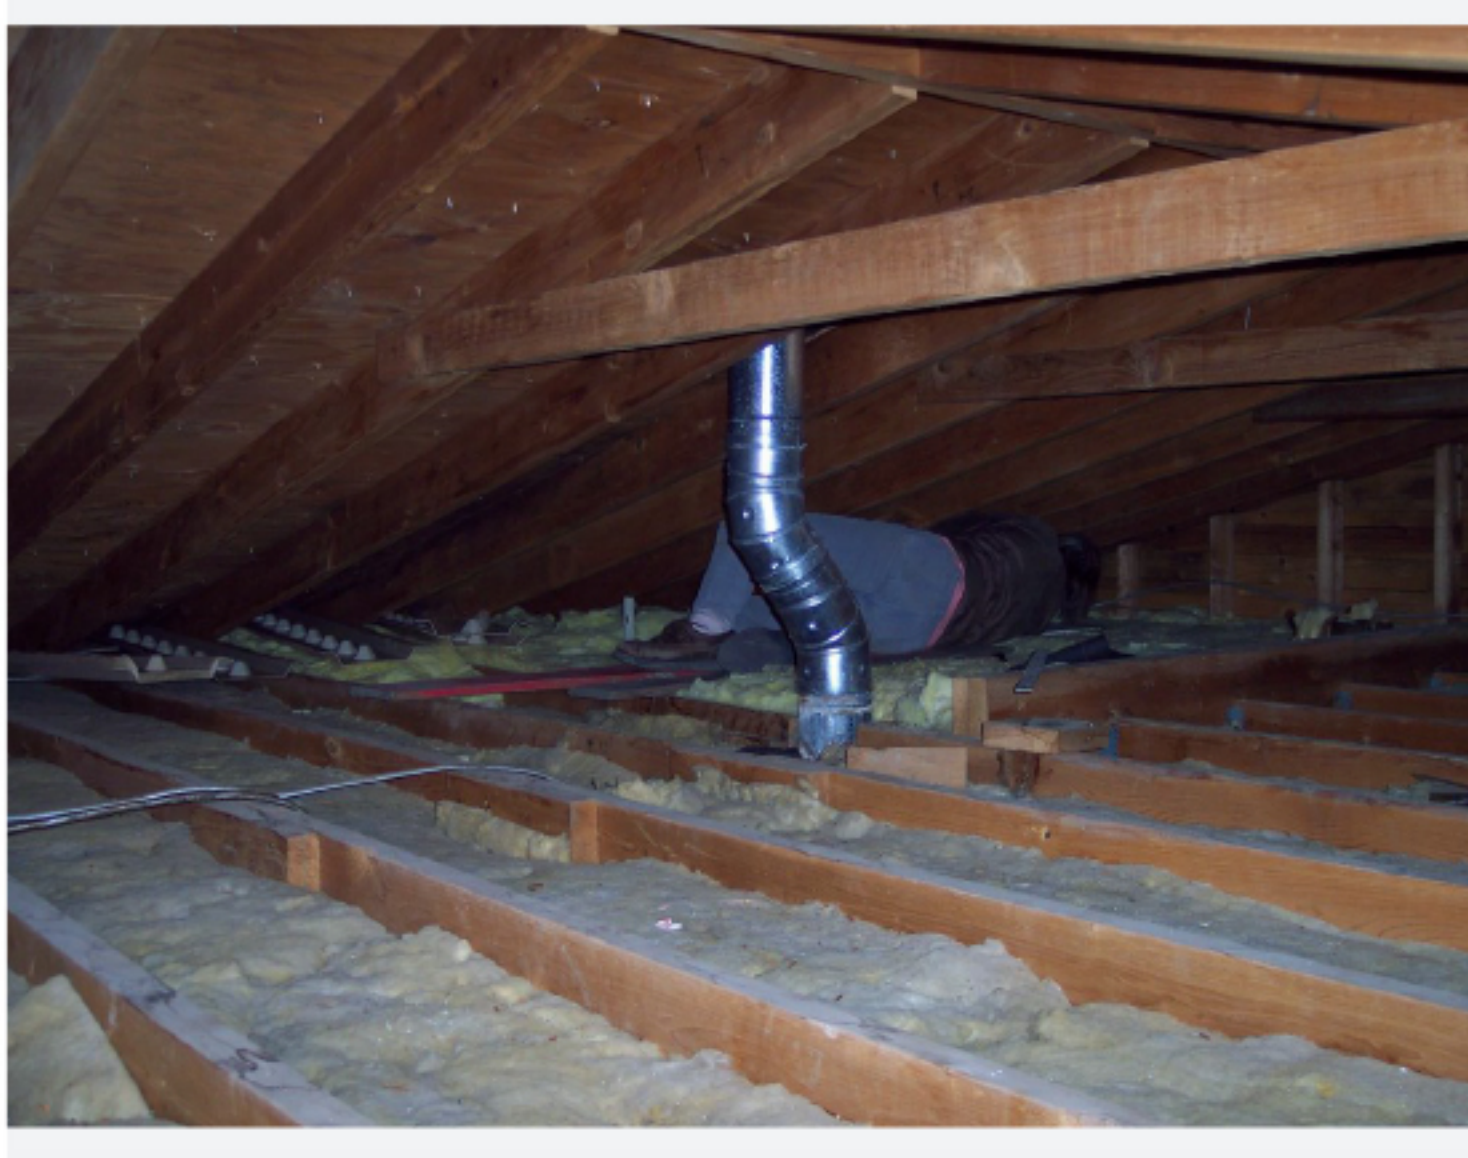
### 8.3 INSULATION

- Recommend additional insulation be installed in the attic. See an insulation specialist for installation.

**Recommendation**

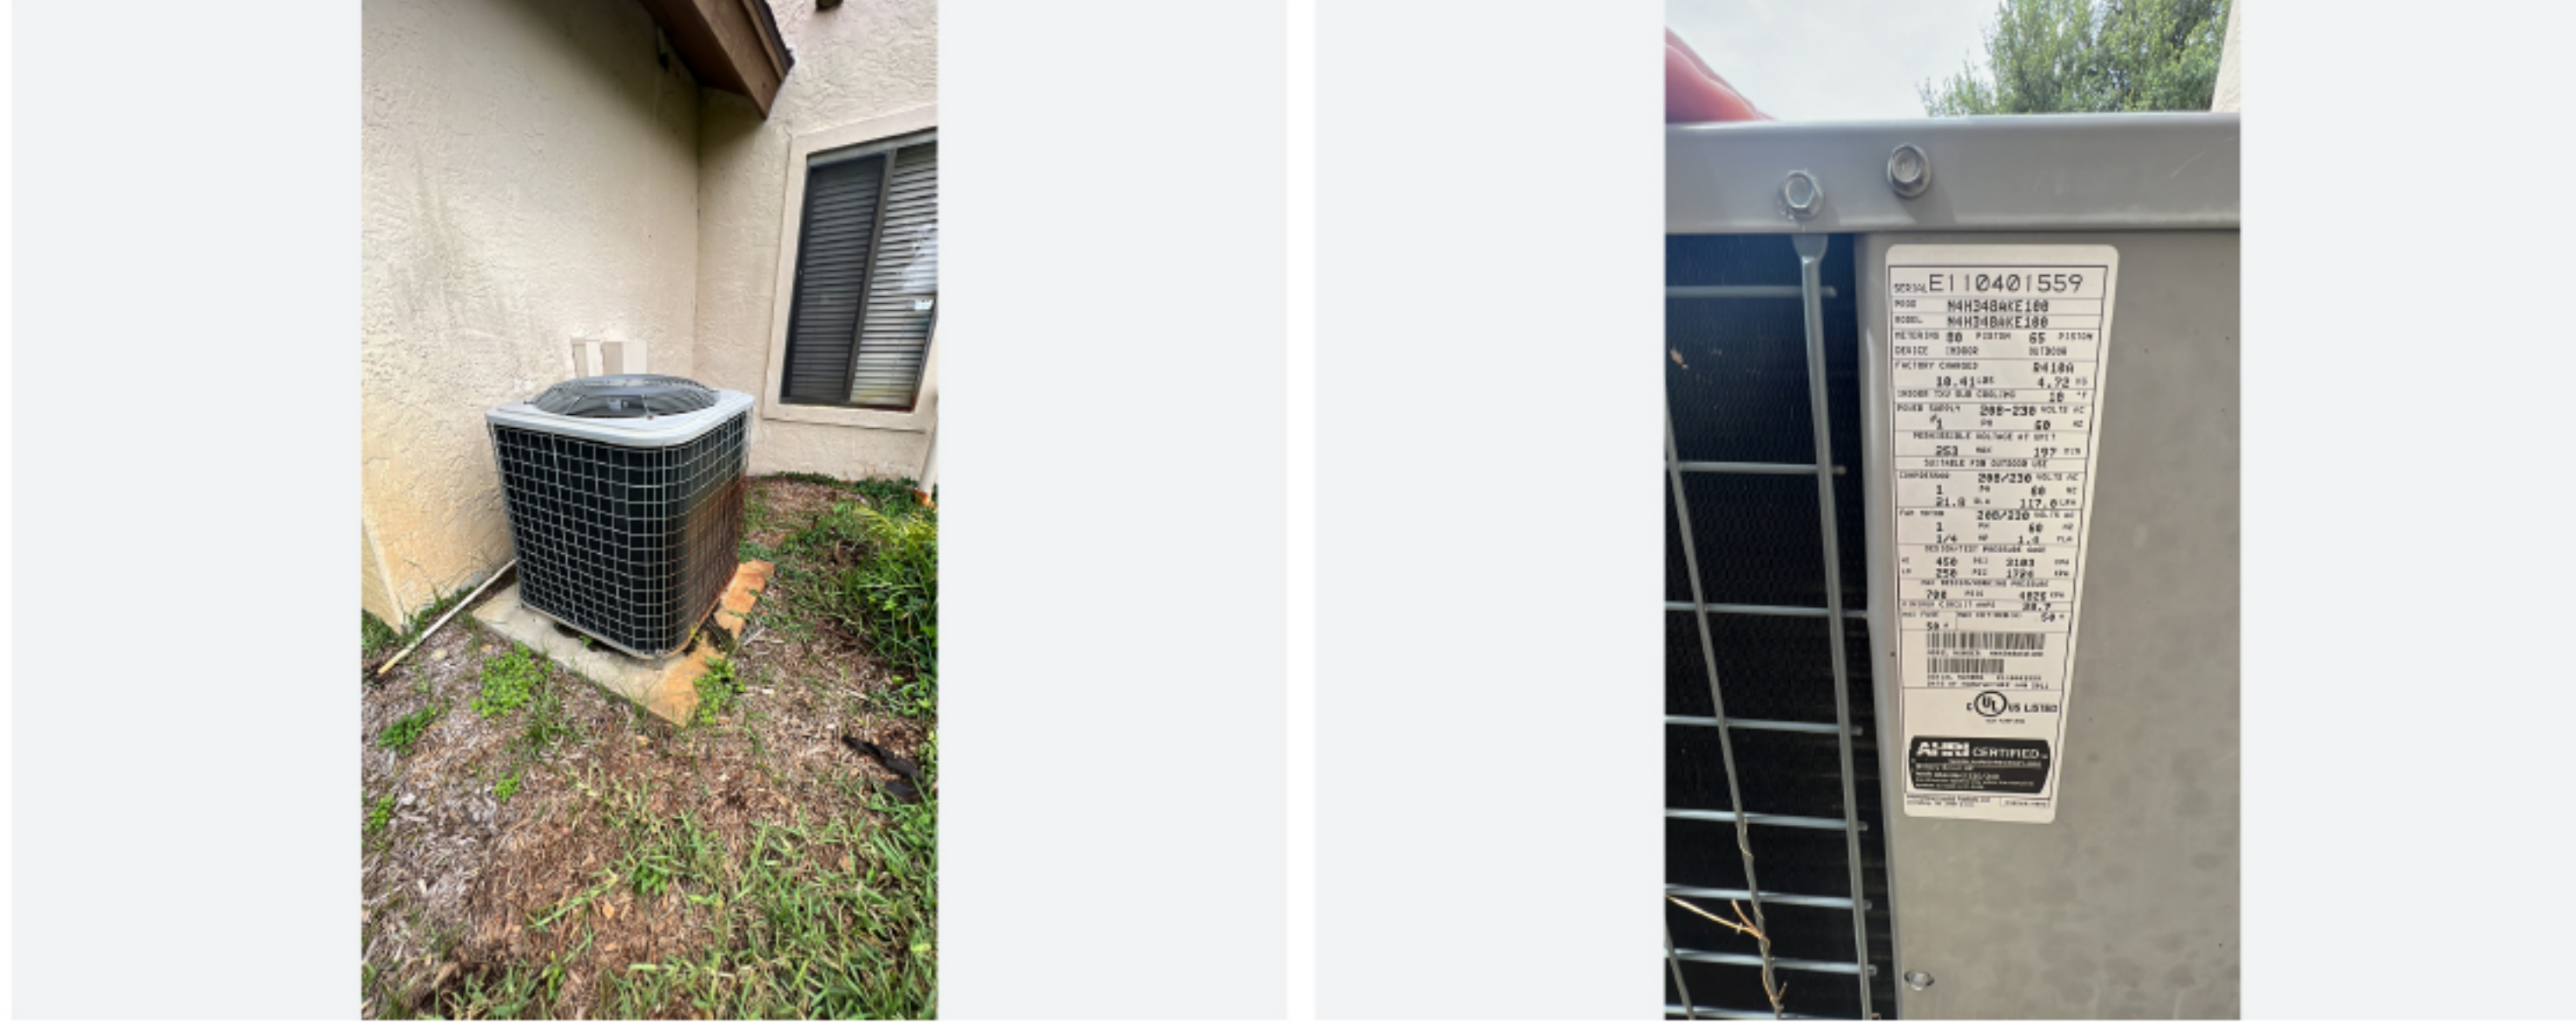
## 9.4 COOLING SYSTEM

- Unit is nearing the end of its design life

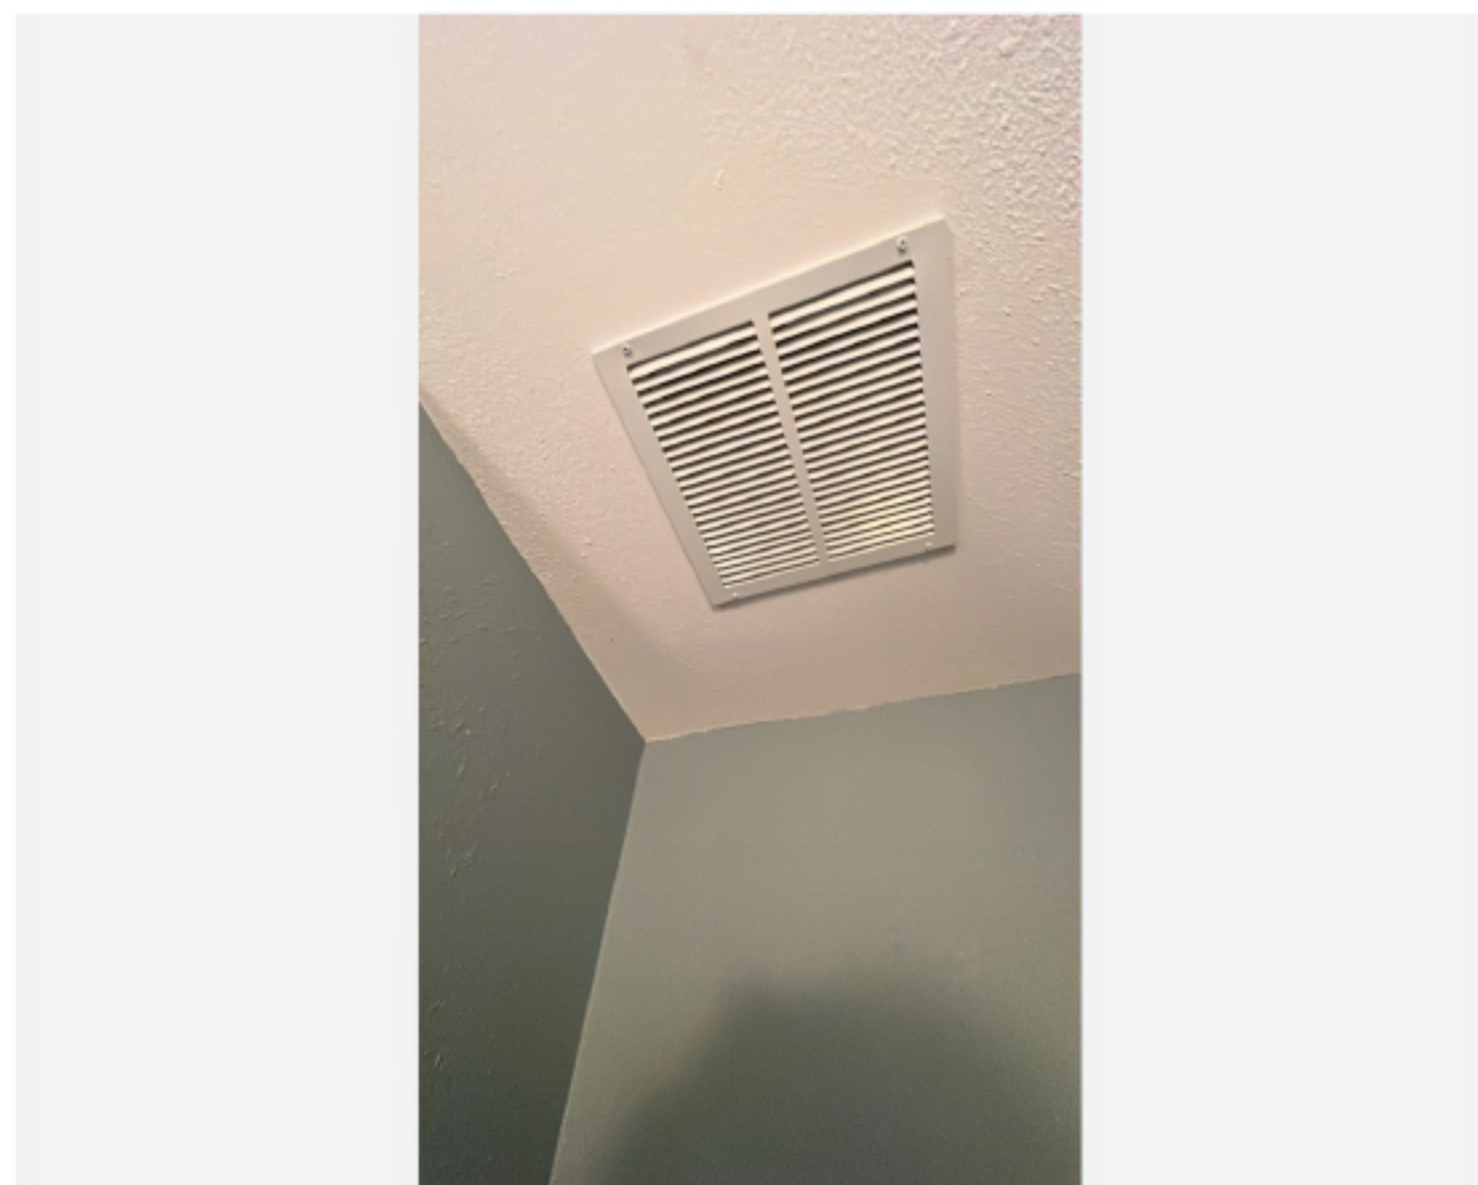
Location - 1st Floor, Bathroom

- Fan inoperative in the first floor half bathroom. Recommend repair/replacement by a licensed contractor.

Recommendation

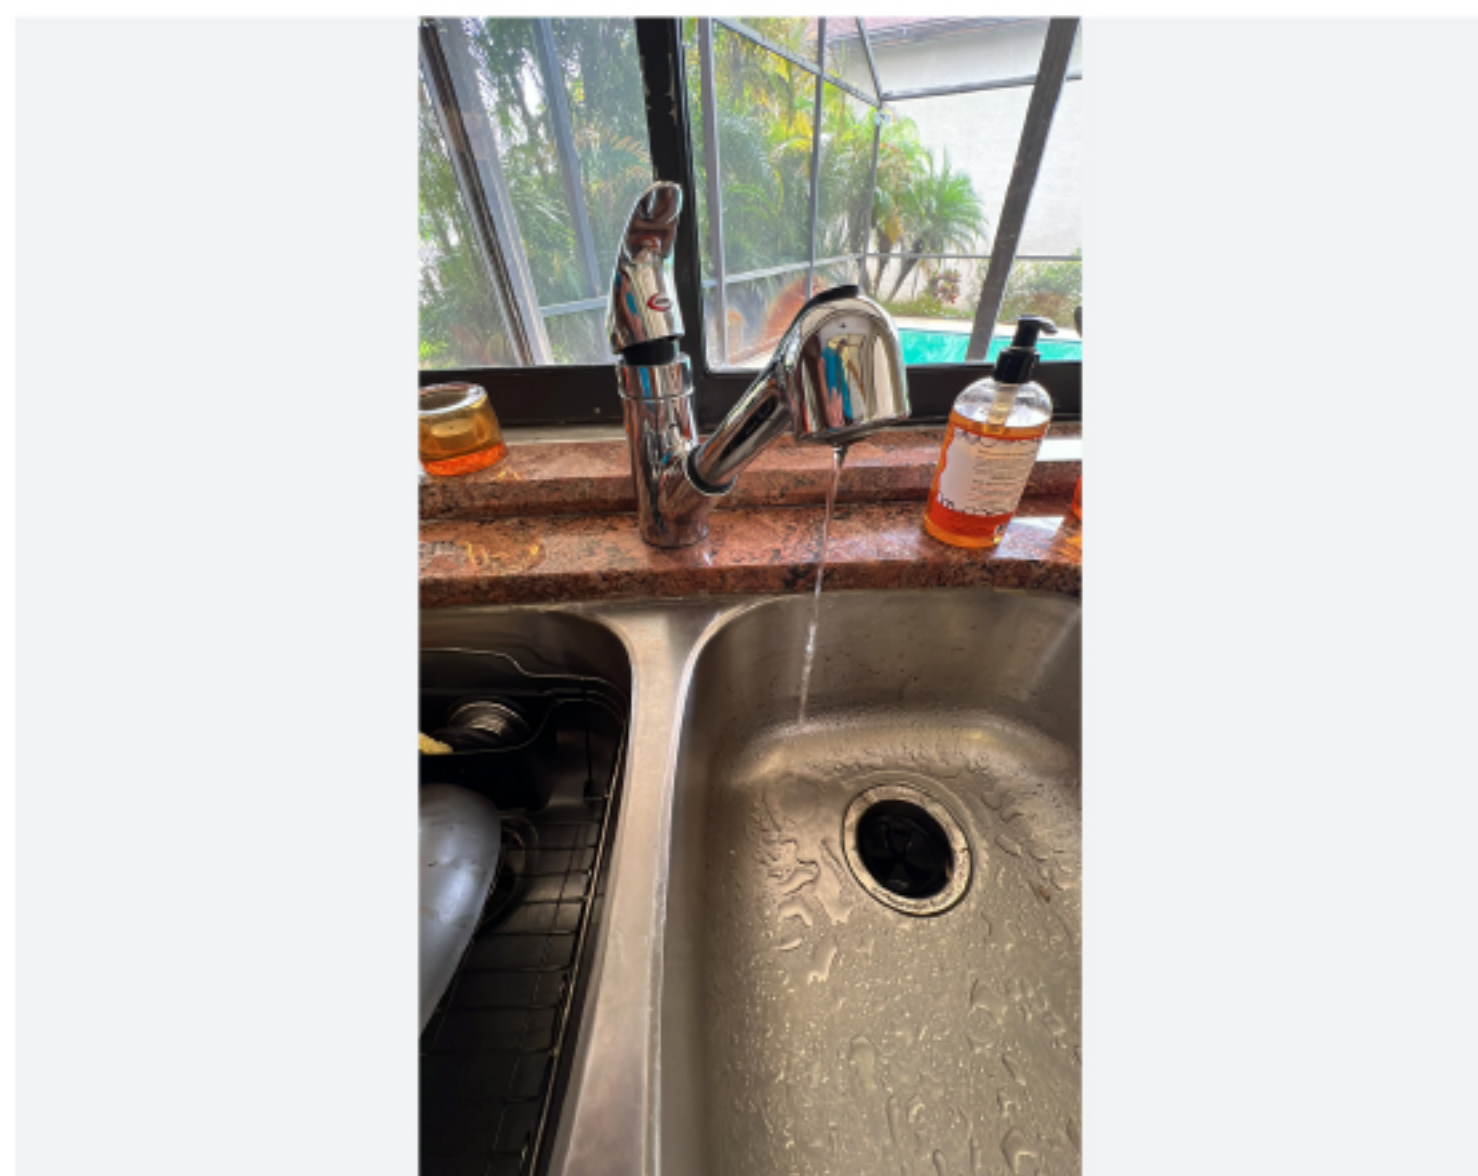
Location - Kitchen

- **Low Water Pressure**  
Low water pressure was noted at the kitchen sink when the water filtration system backflushes. Recommend evaluation and repair by a licensed plumber.

Requires Attention

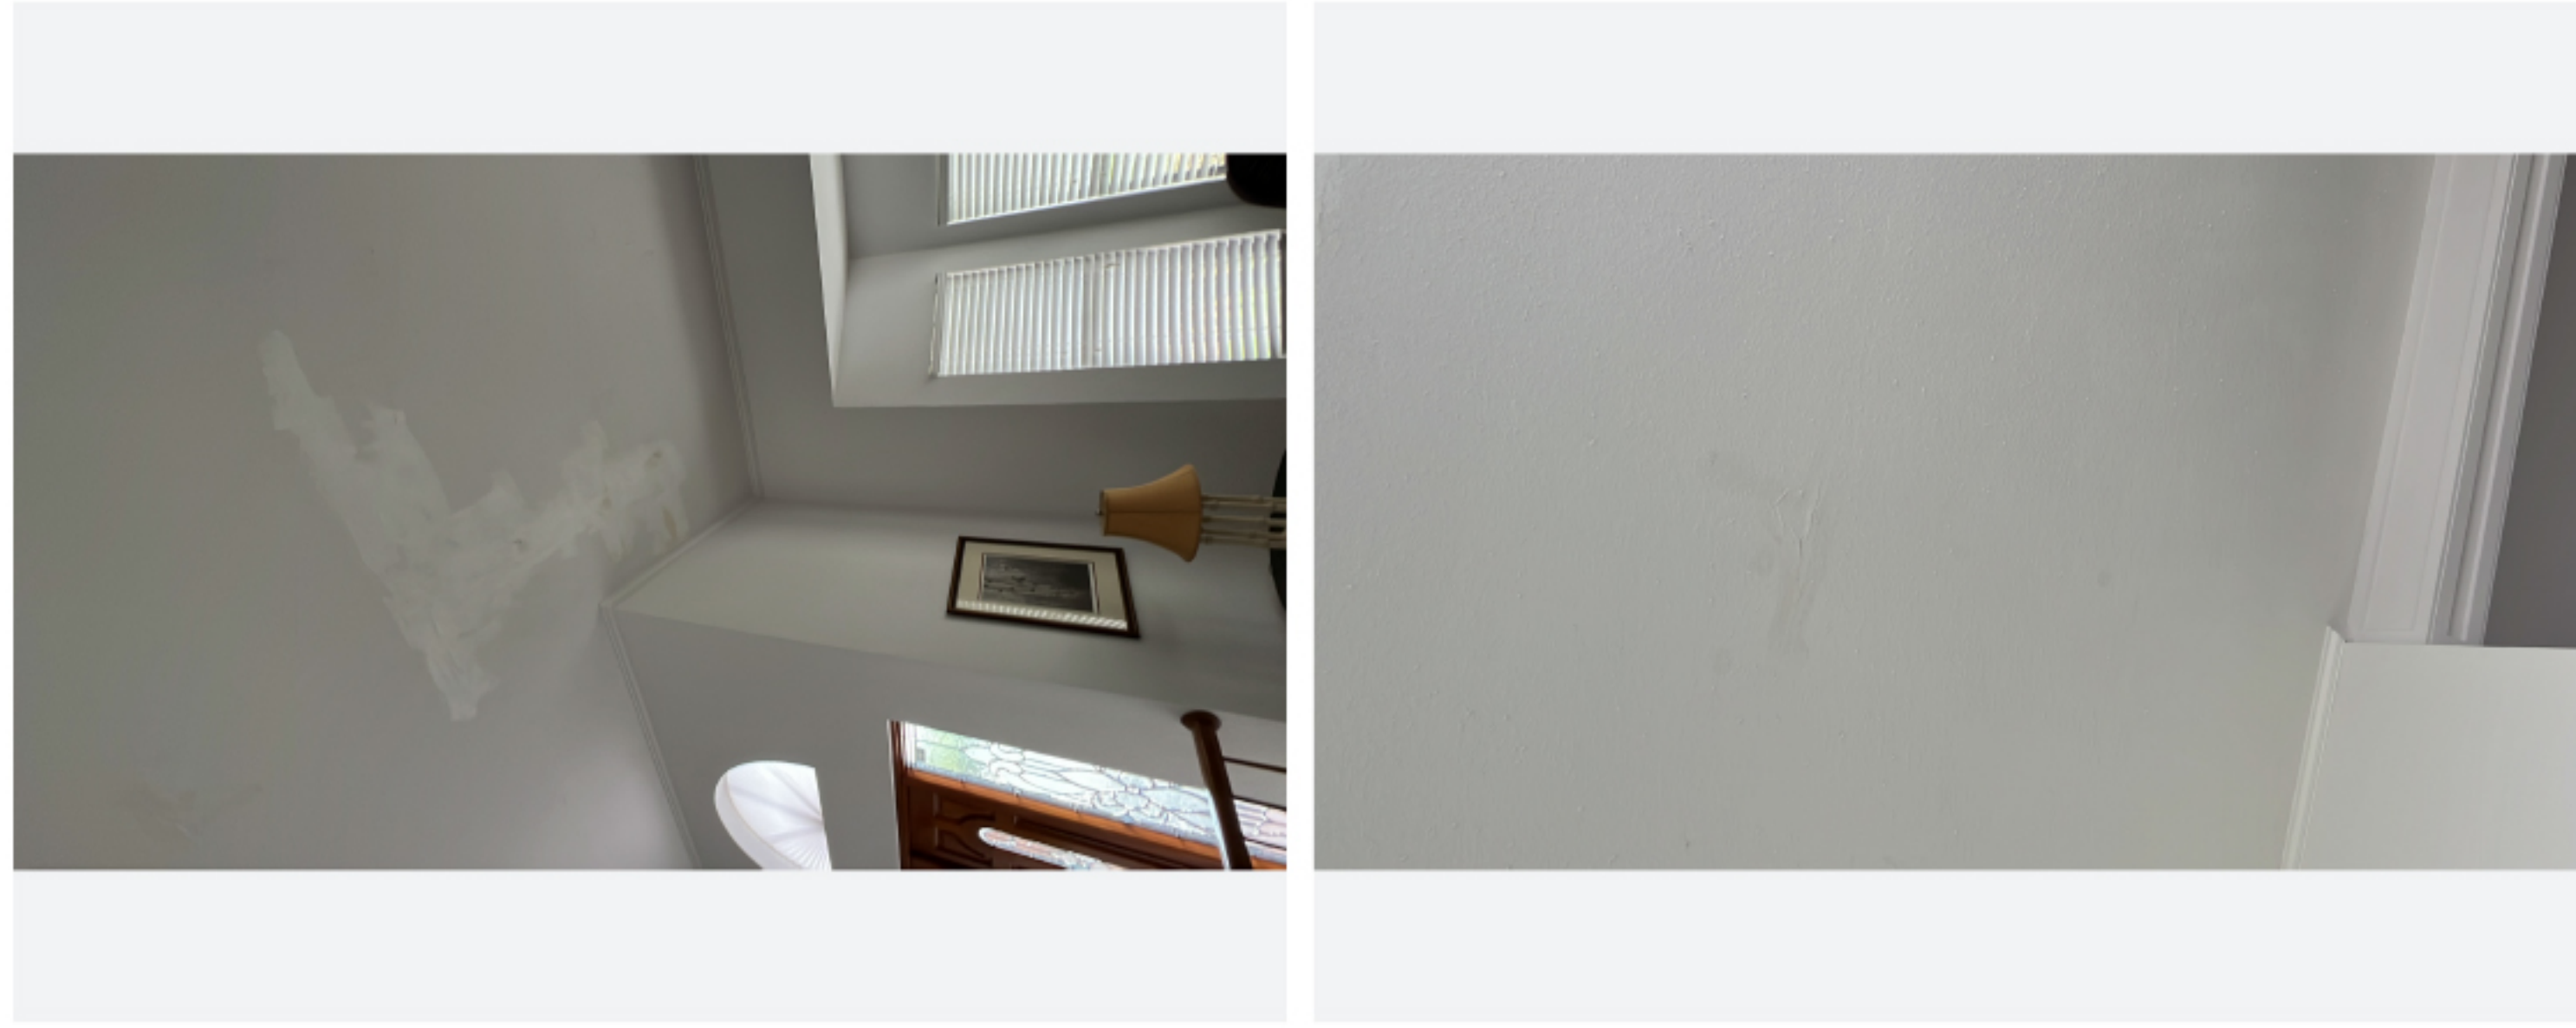
Location - Living room

- Nail pop(s) observed

- Evidence of past or present water damage

Requires Attention
