Jun 20th, 2023

1234 Skywalker Drive, Tampa, 34654

# Home Inspection Report

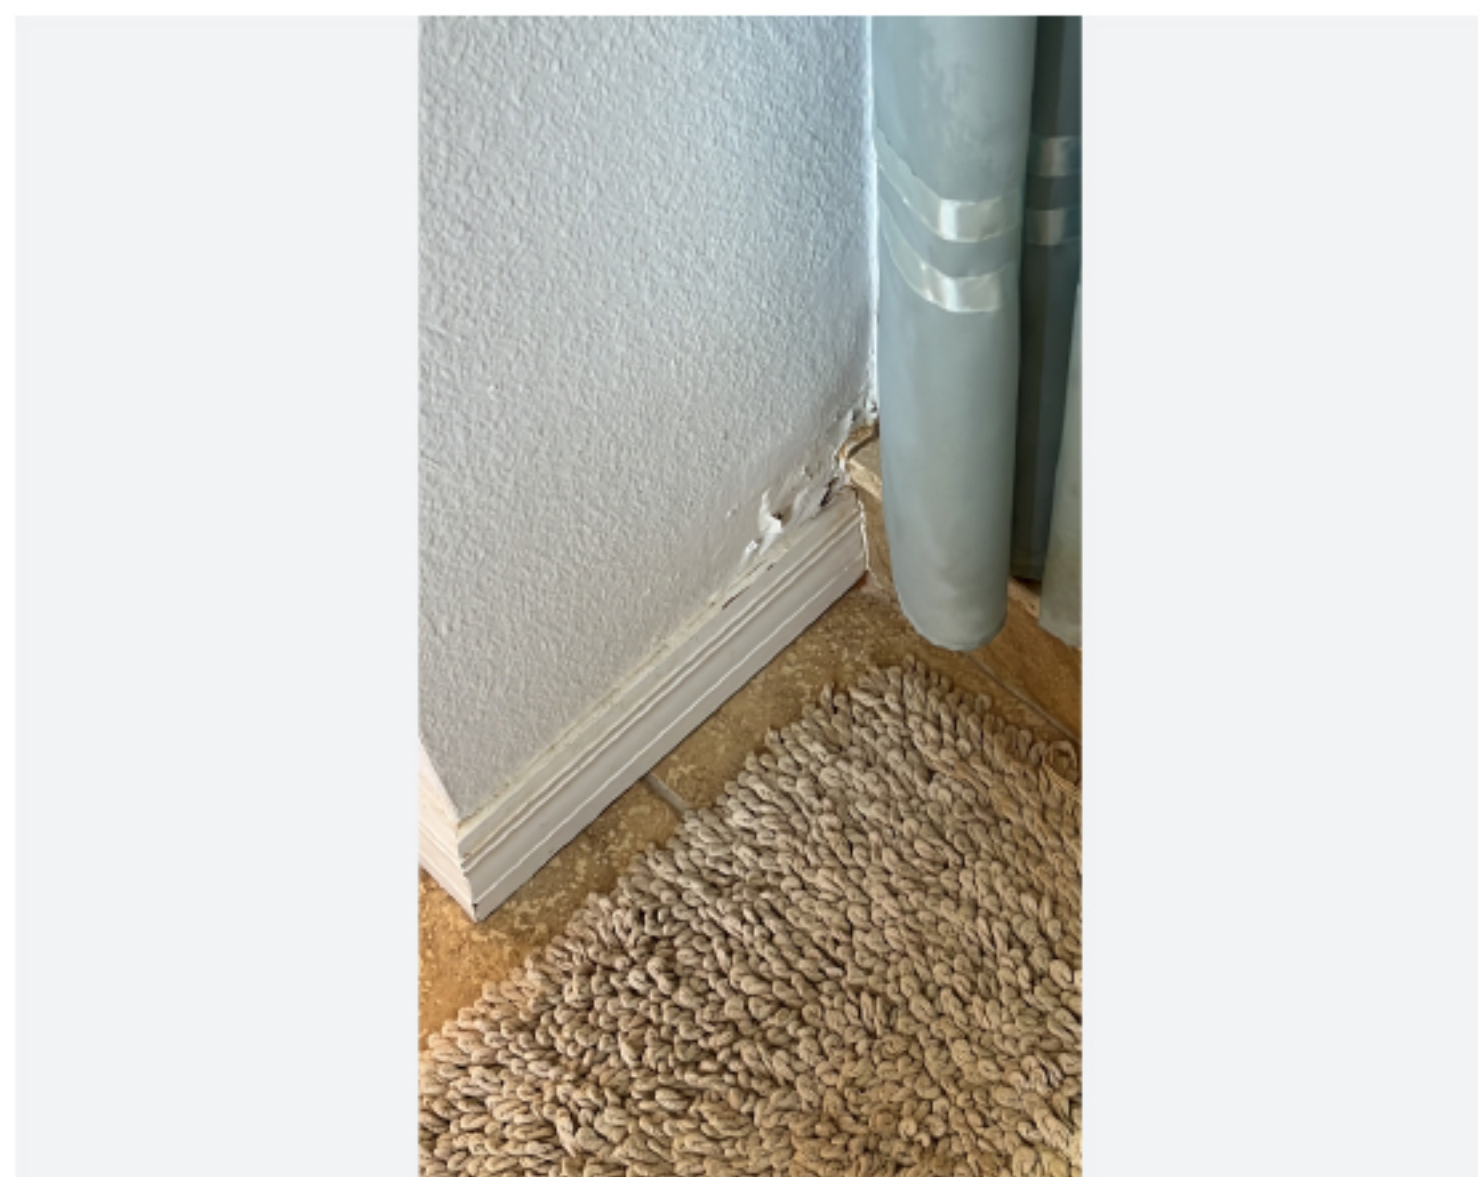
Location - Master, Bathroom

- **Peeling Paint in Master Bathroom**  
Peeling paint was noted by the shower in the primary en suite. Recommend sanding and repainting by a qualified handyman or painter.

Recommendation

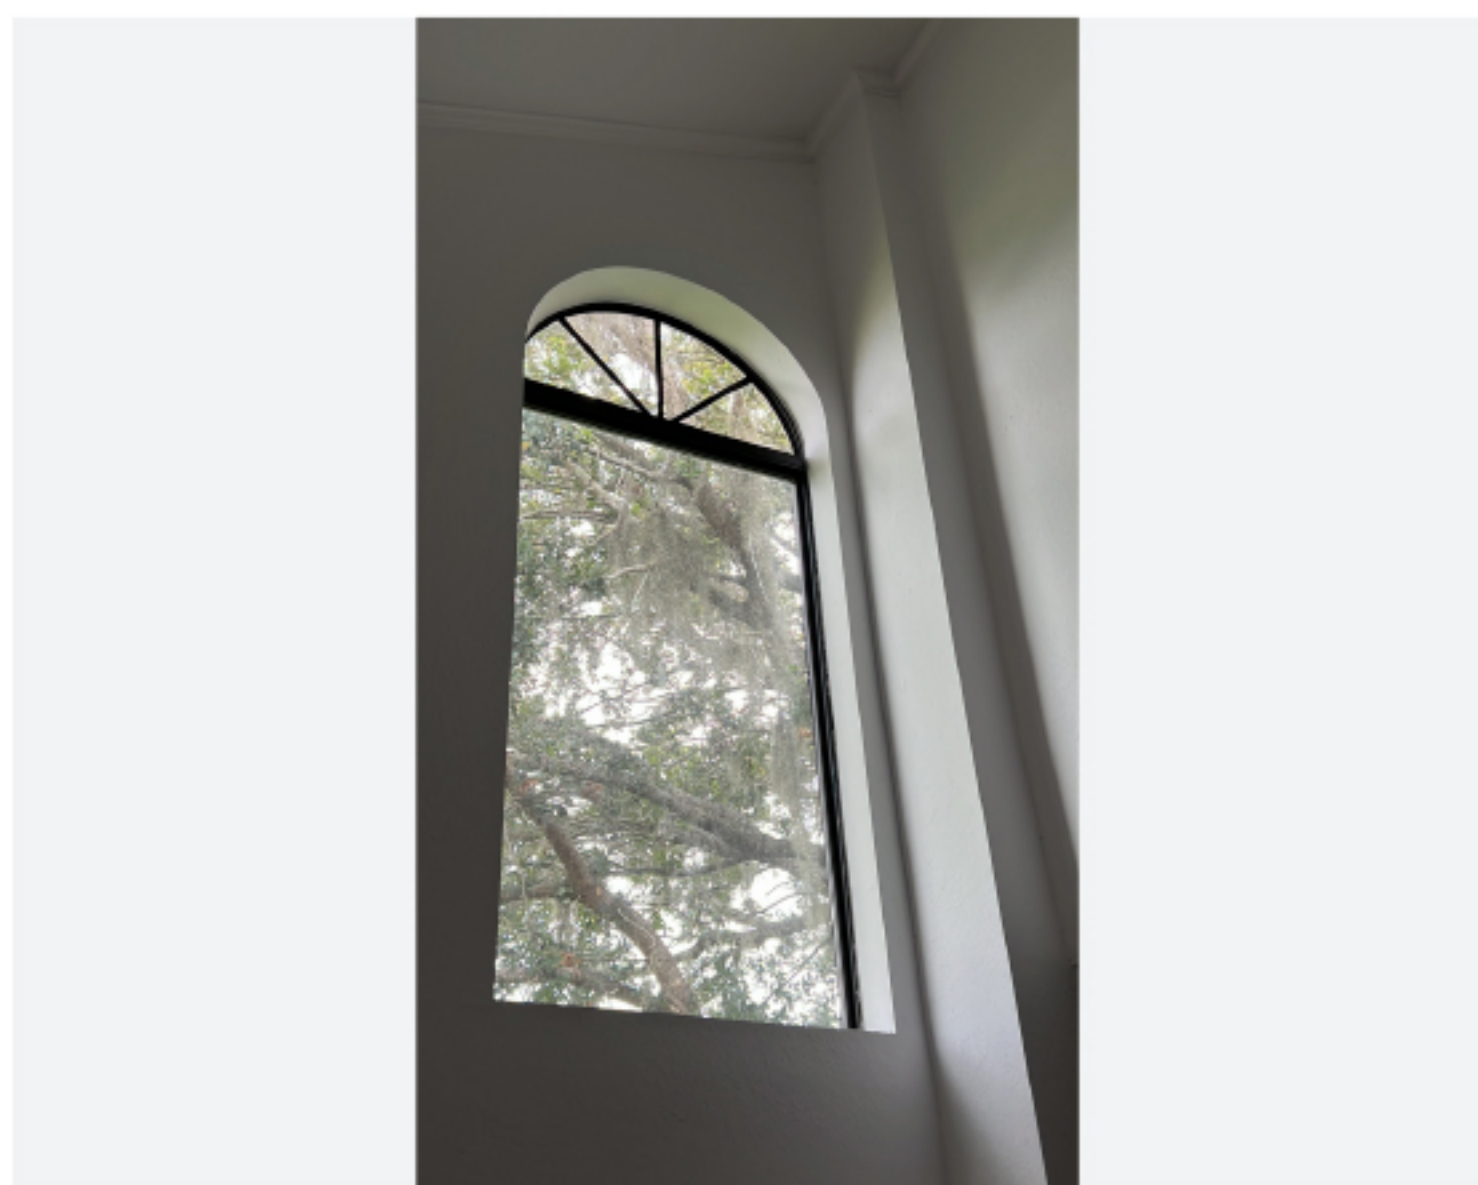
Location - Living room

- **Cracked Living Room Window**  
Cracked, broken, or missing glass

Requires Attention

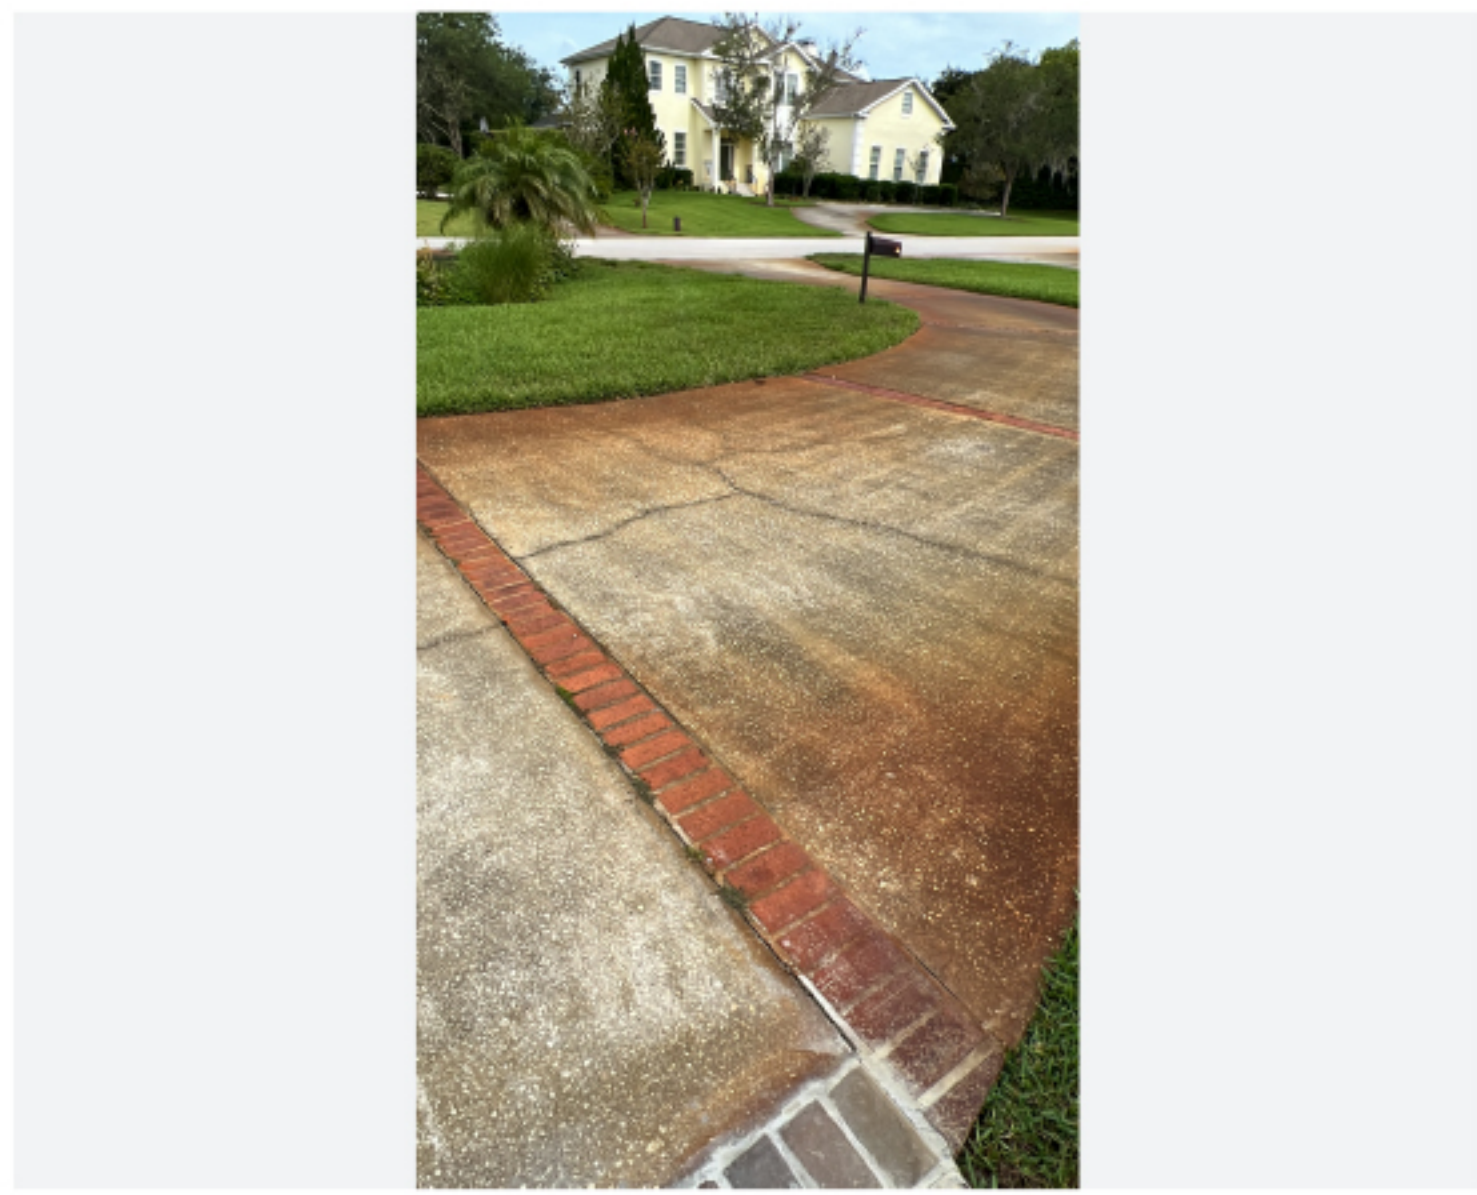
## 1.1 DRIVEWAY

- Typical cracking noted

Requires Attention

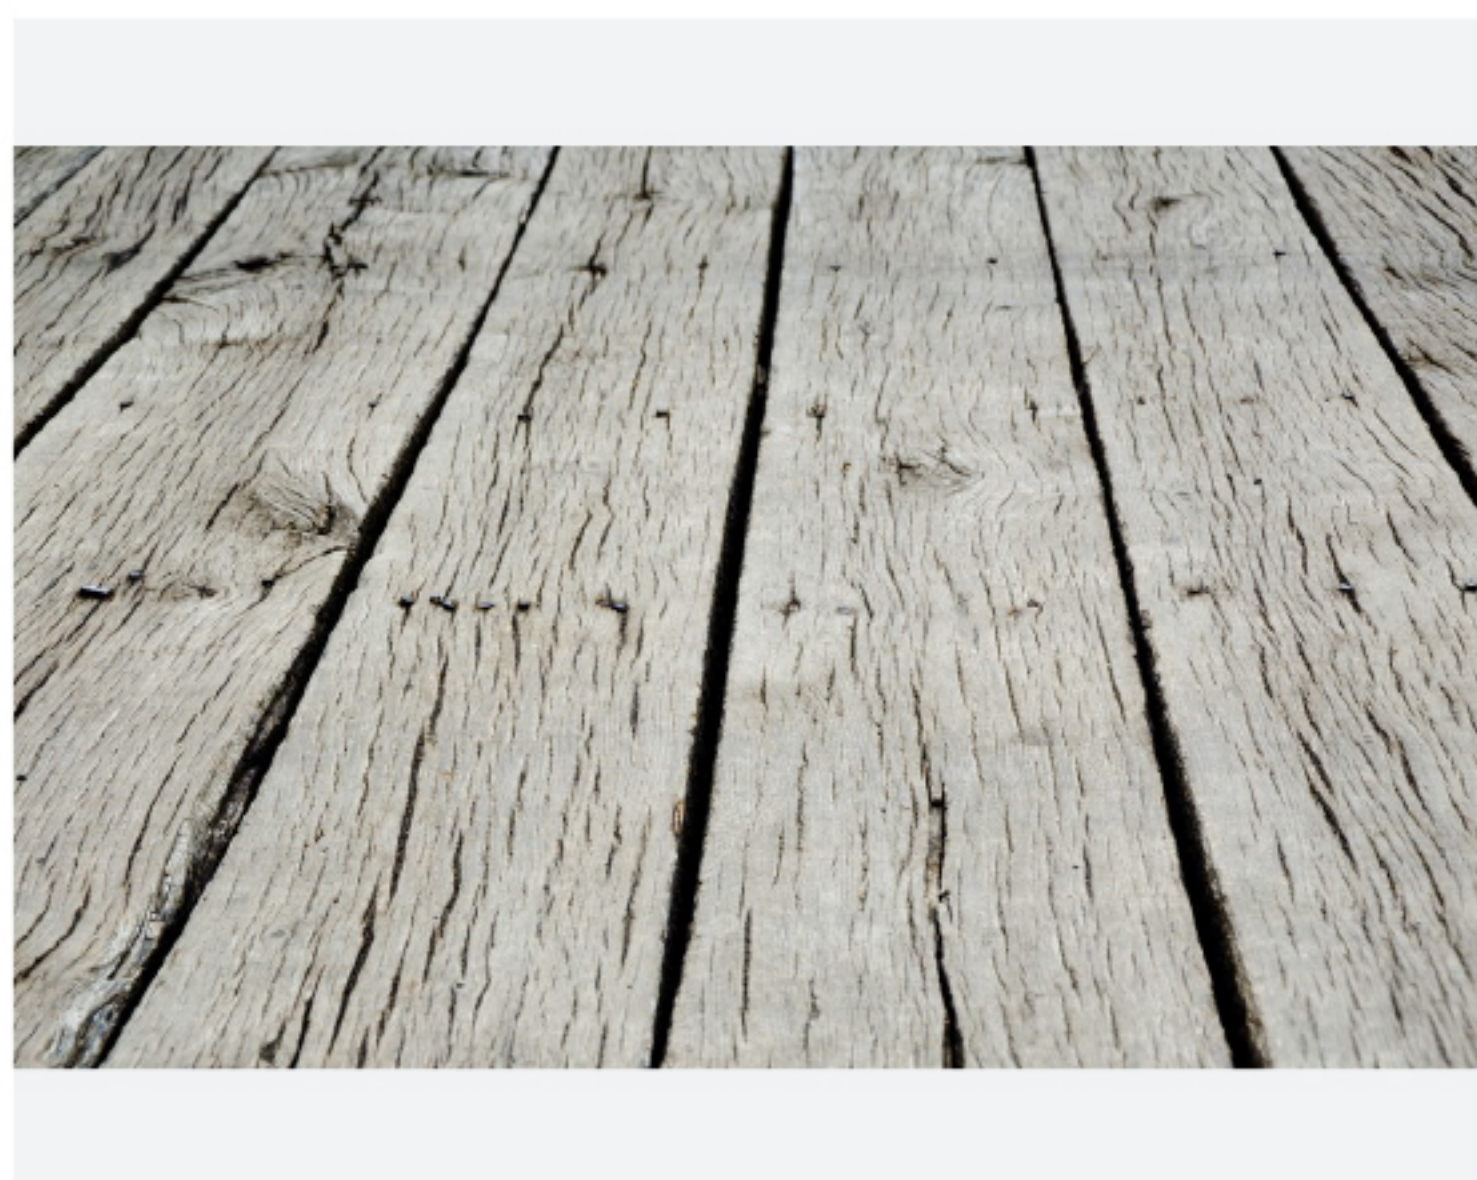
## 1.6 DECK/BALCONY

- **Moisture damage**  
Significant moisture damage and wood rot was noted at the deck. Recommend evaluation and repair by a licensed contractor or deck specialist.

Safety

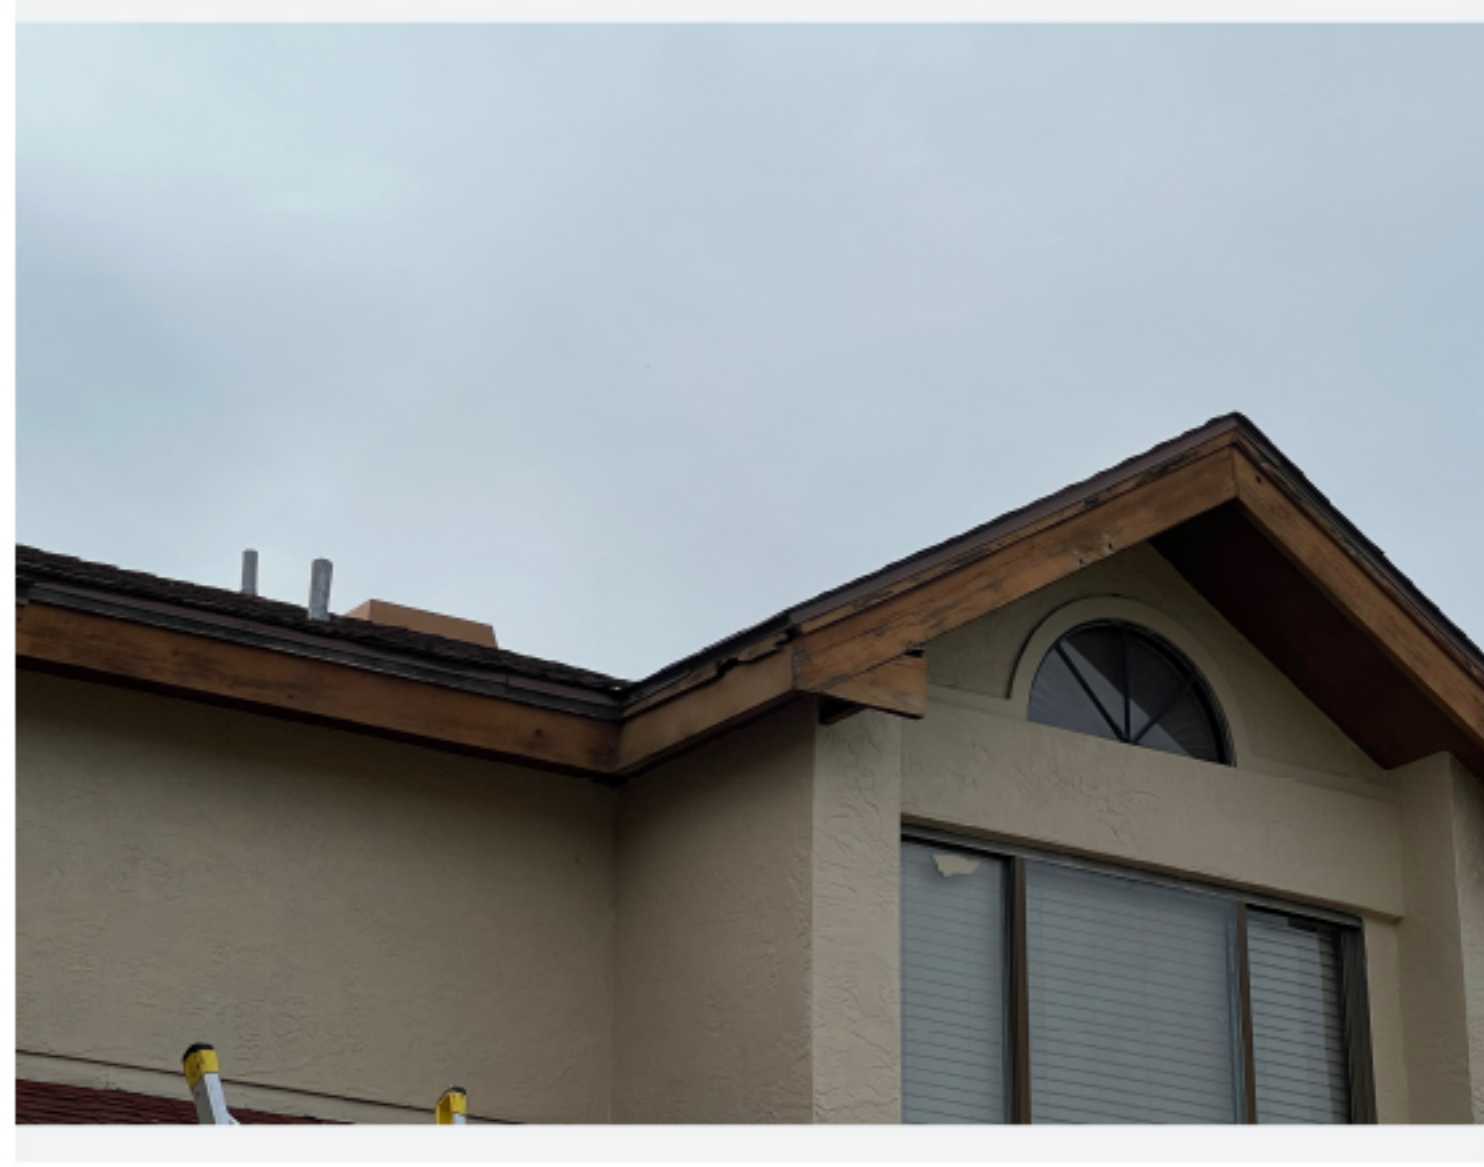
## 2.2 SOFFITS/FASCIA

Requires Attention

Wood rot was noted at portions of the fascia trim. See a licensed contractor for evaluation and repair/replacement as needed.

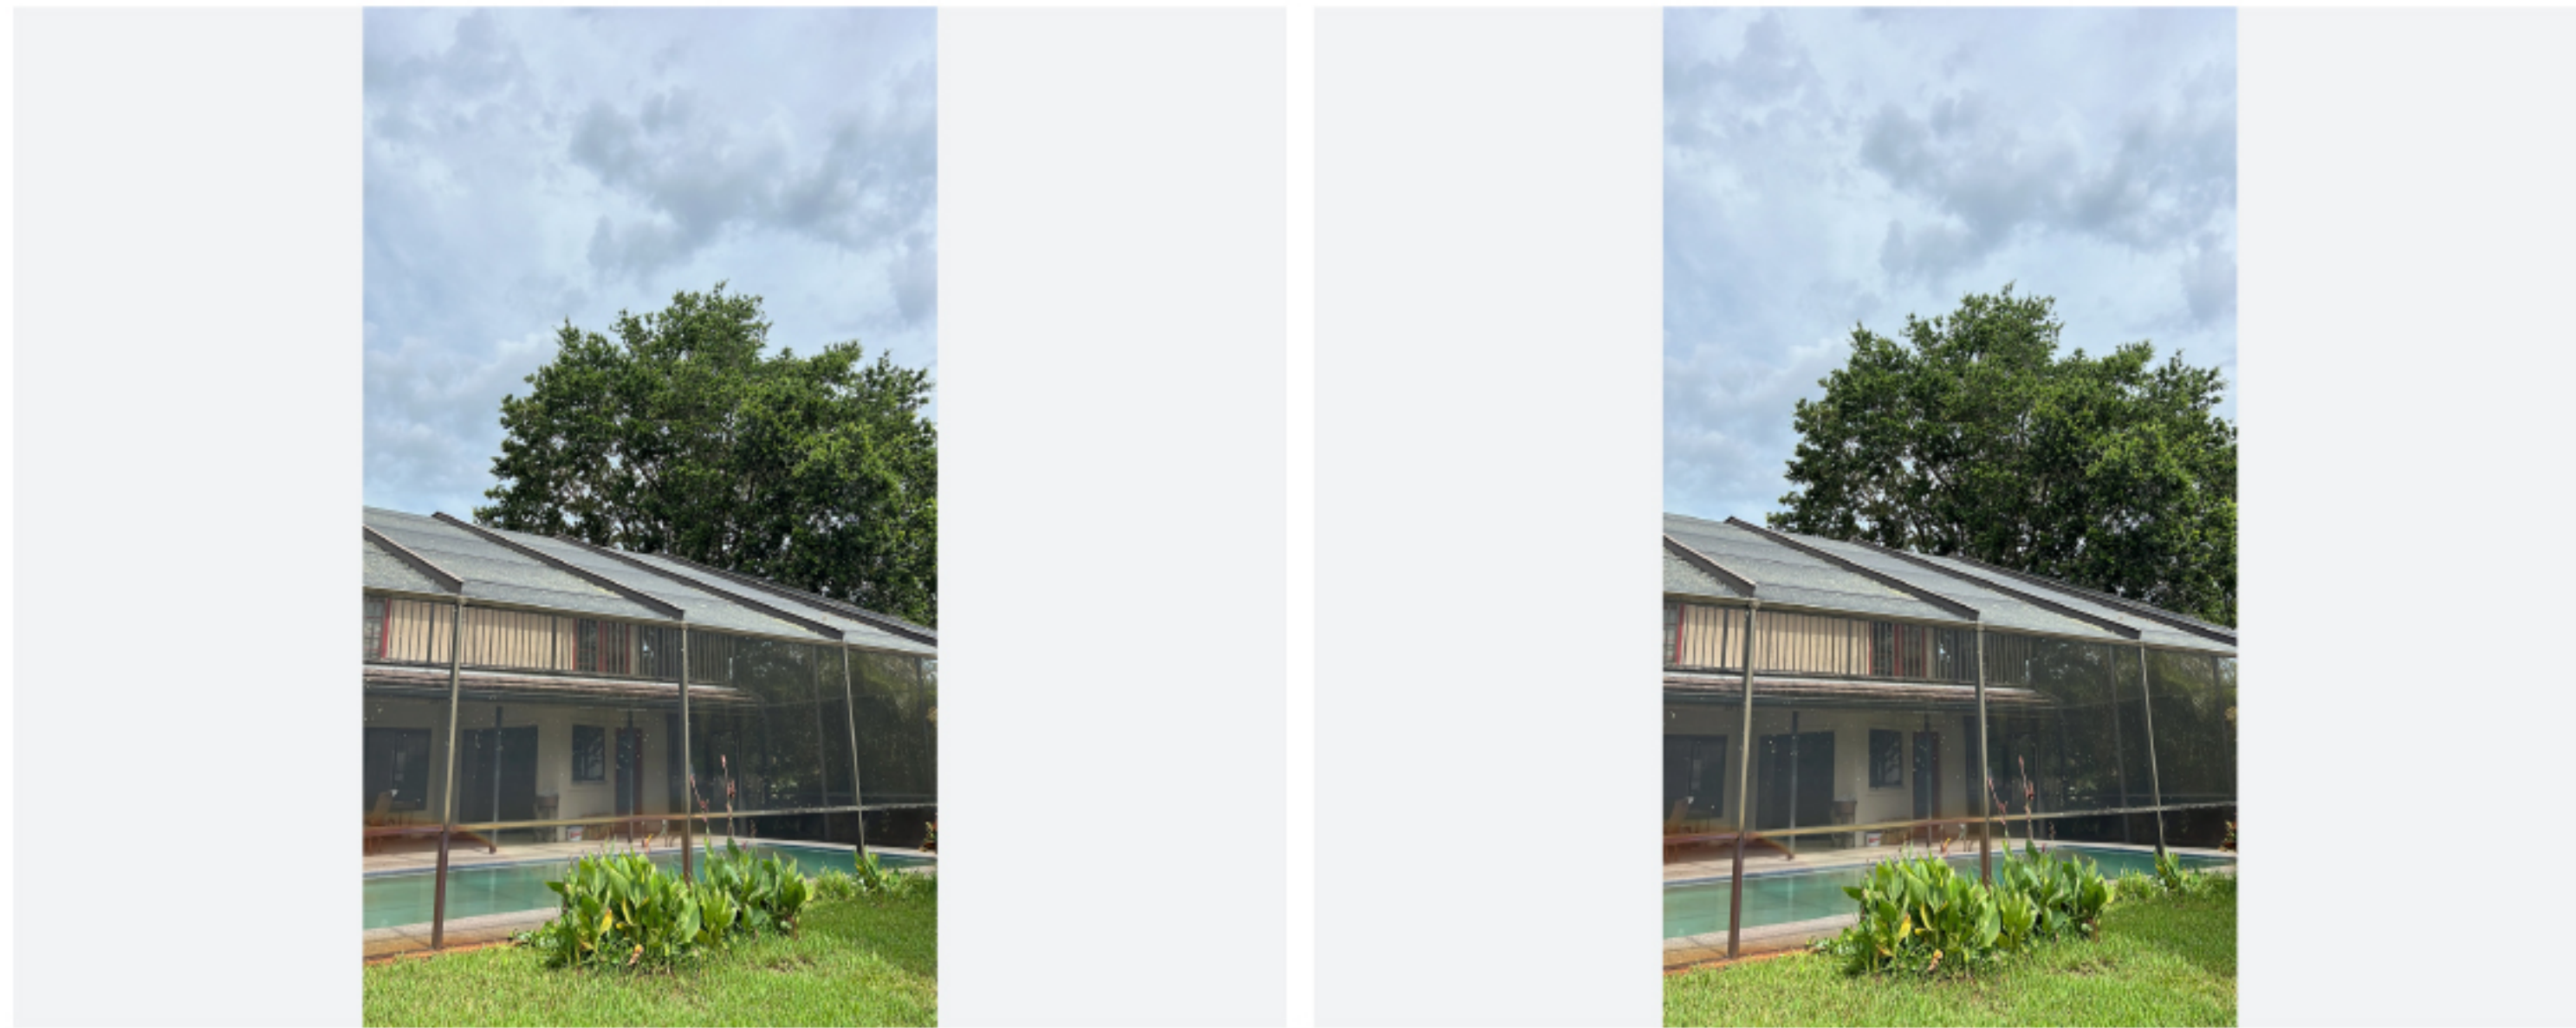
## 2.5 TREES AND VEGETATION

- **Overgrown/Overhanging Tree Limbs**  
Tree limbs are overhanging the roof and could damage roofing material. Recommend evaluation by an arborist.

Requires Attention

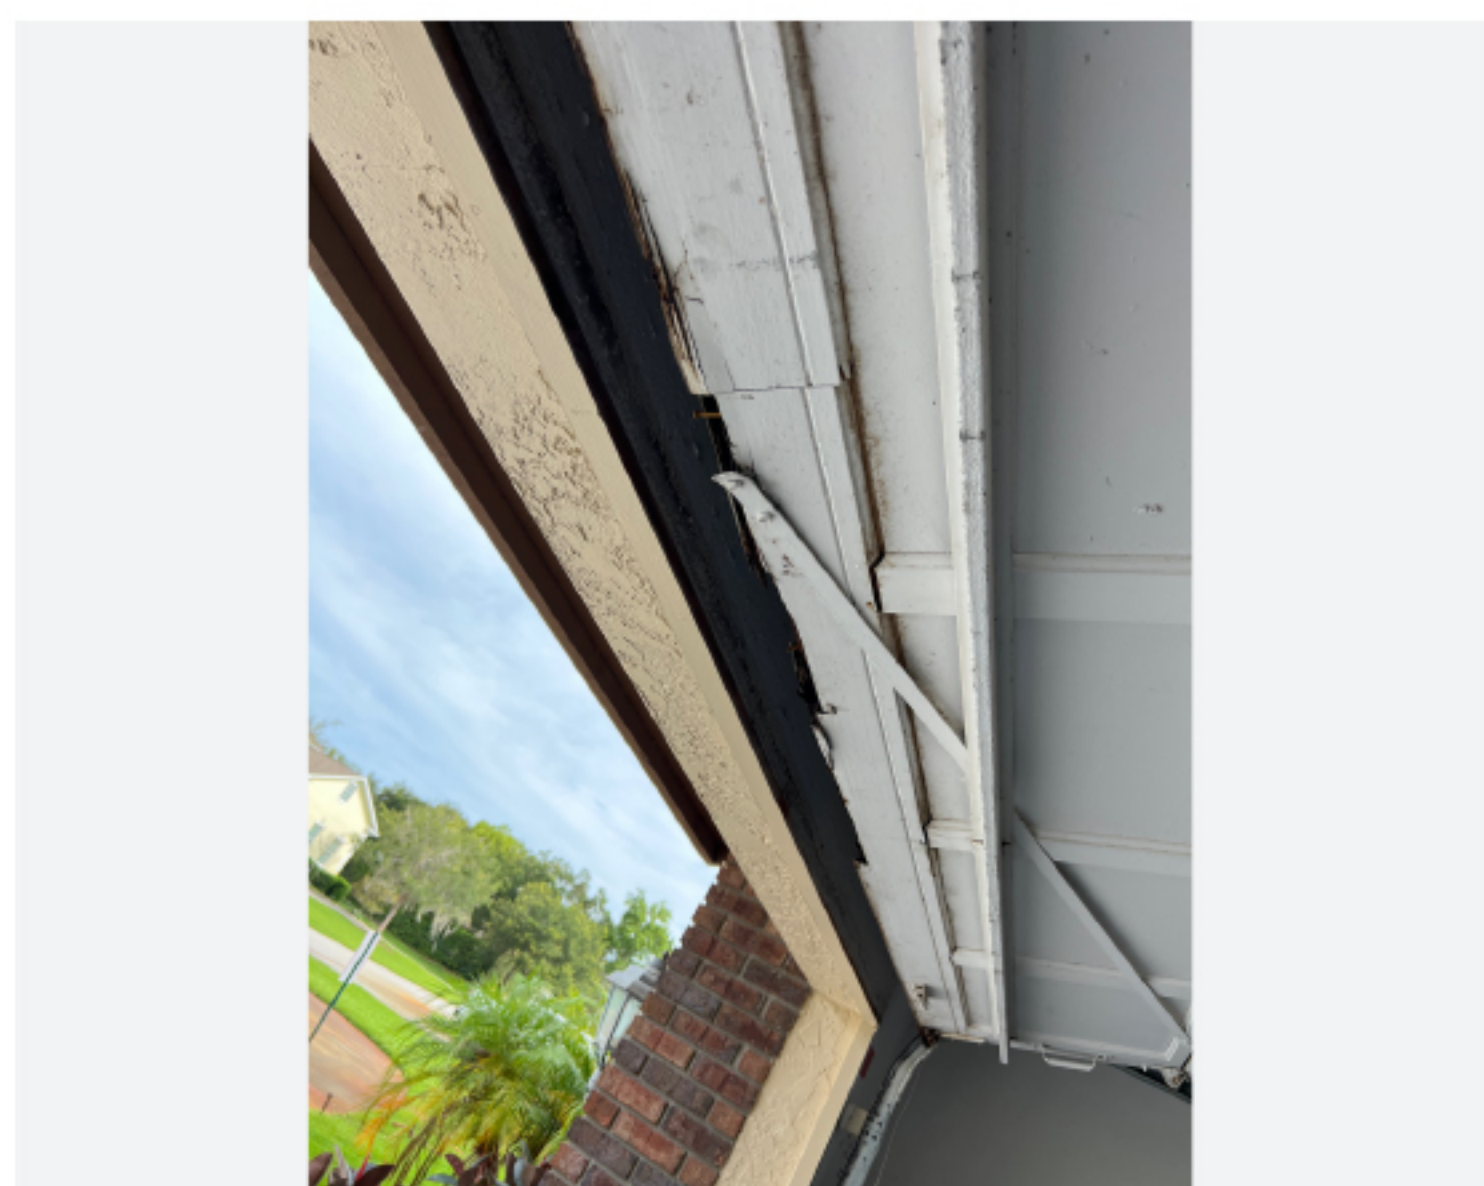
## 4.2 GARAGE DOORS

- **Water Damage to Base of Garage Door**  
Water damage was noted at the base of the garage door. Recommend evaluation and repair by a licensed contractor or garage door specialist.

Requires Attention

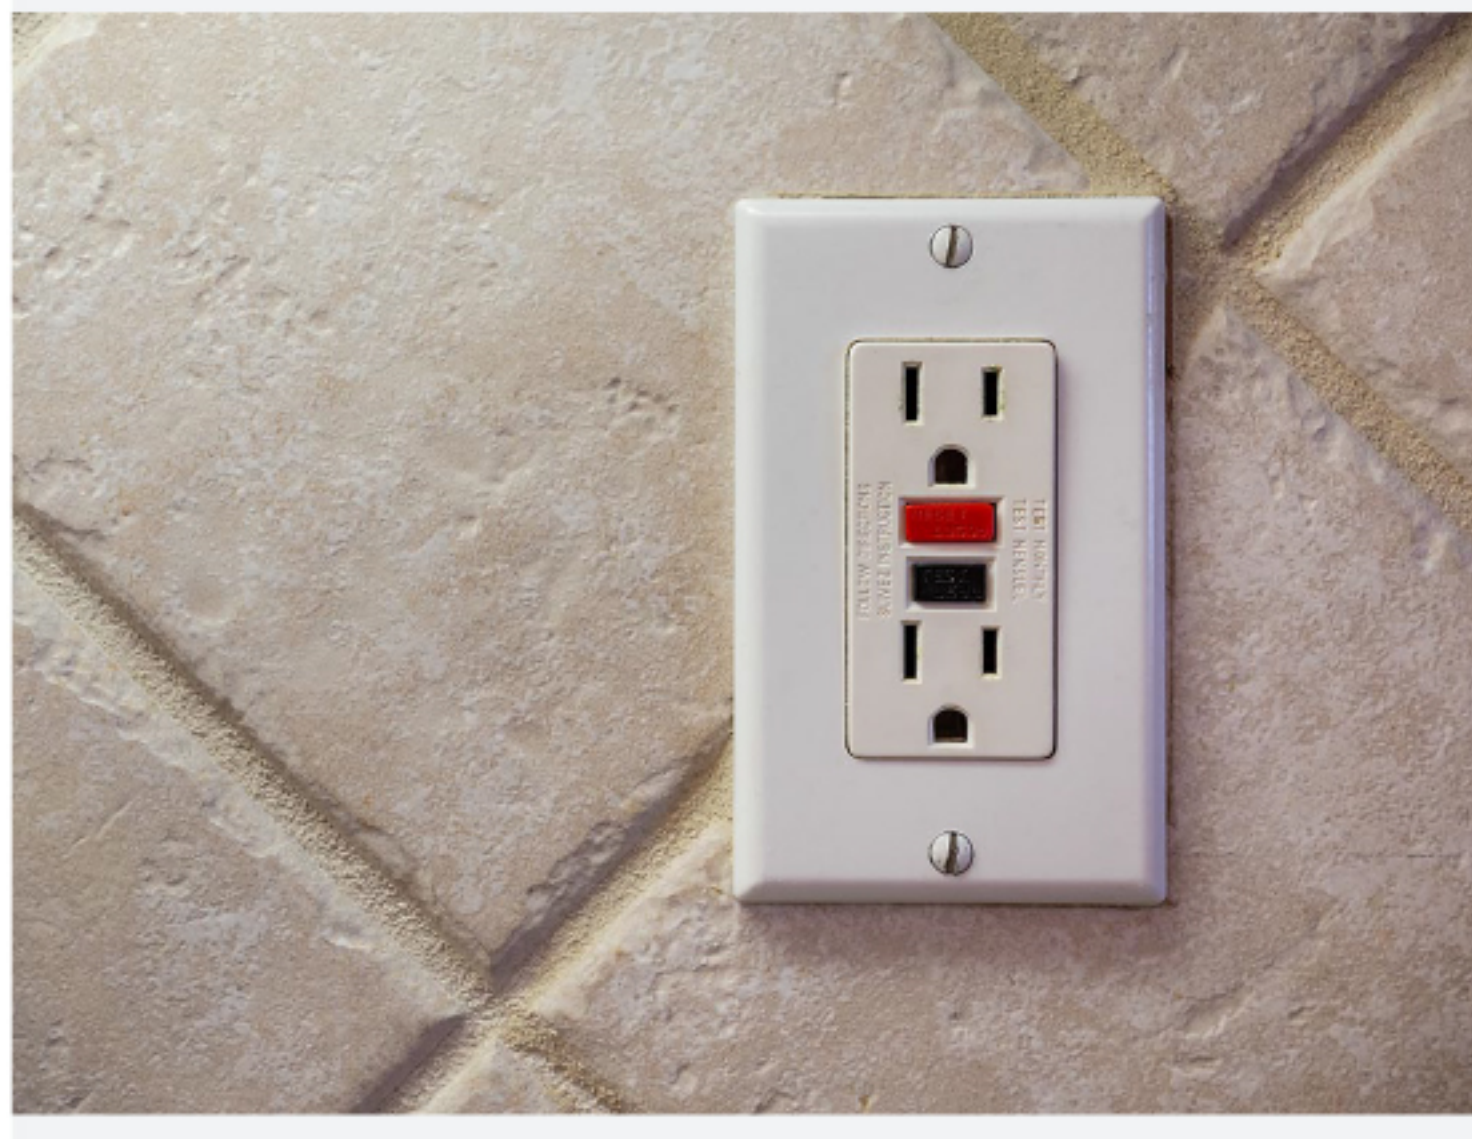
Location - Bathroom

-   Safety

The main level guest bathroom GFCI outlet does not trip when tested. Recommend evaluation and repair by a licensed electrician.

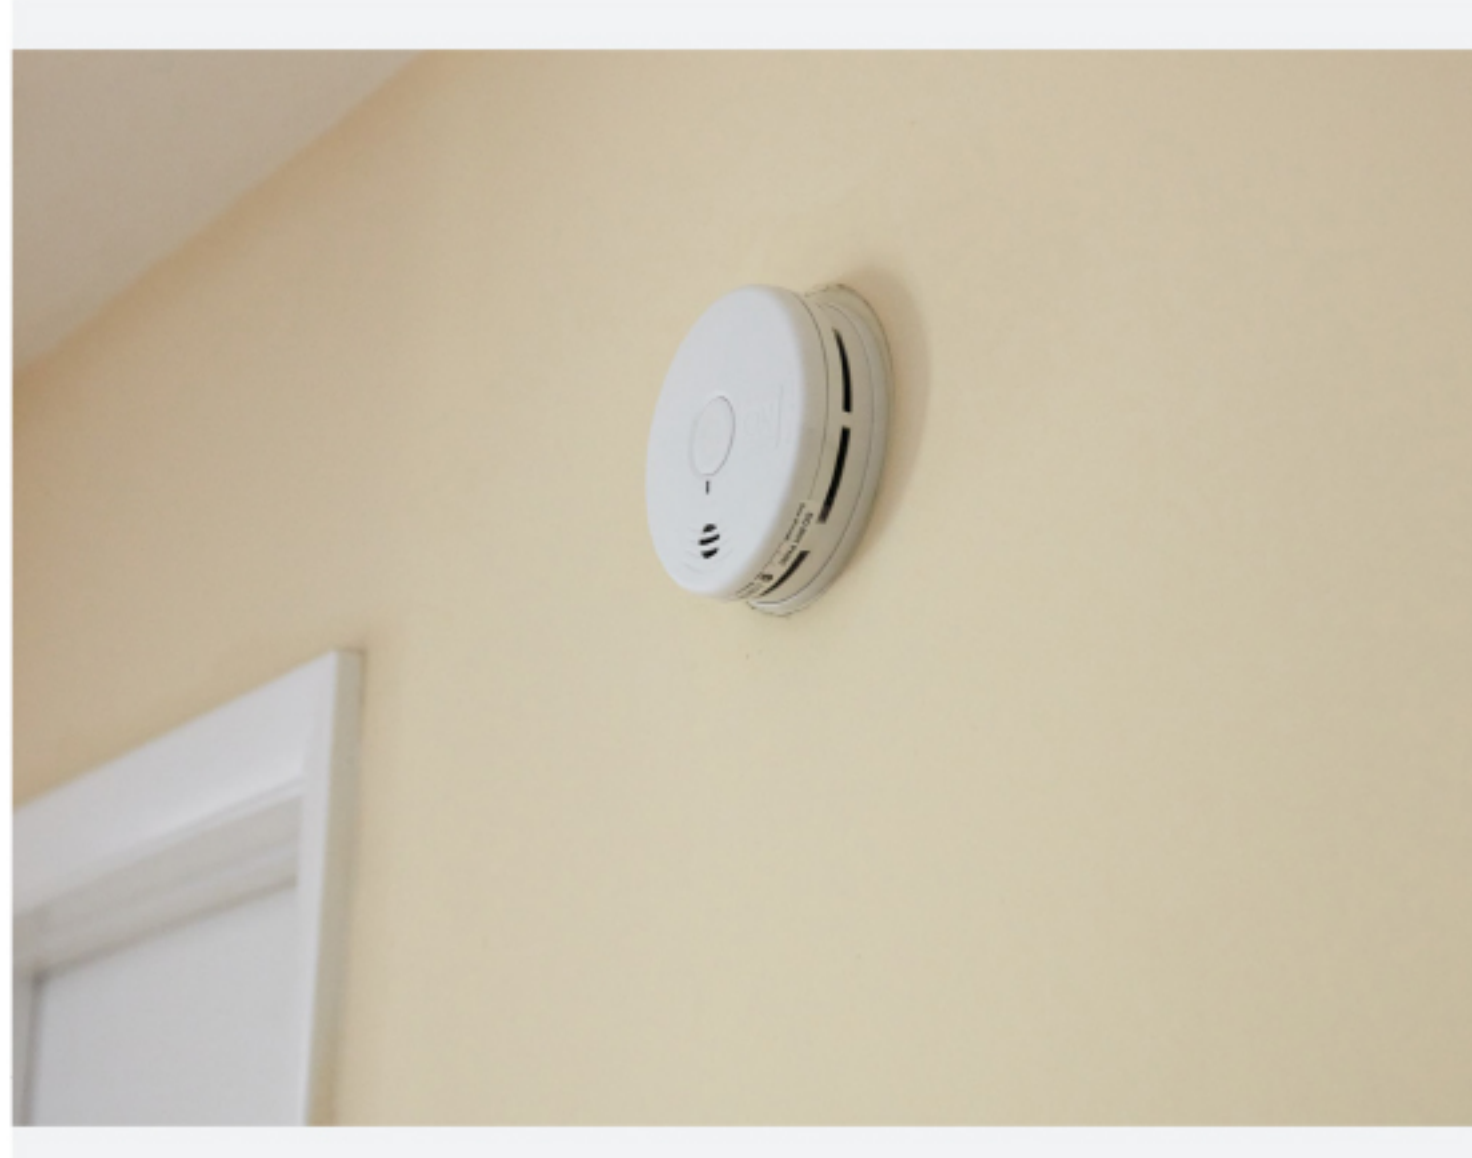
Location - 2nd Floor

- Missing/Low battery

Requires Attention

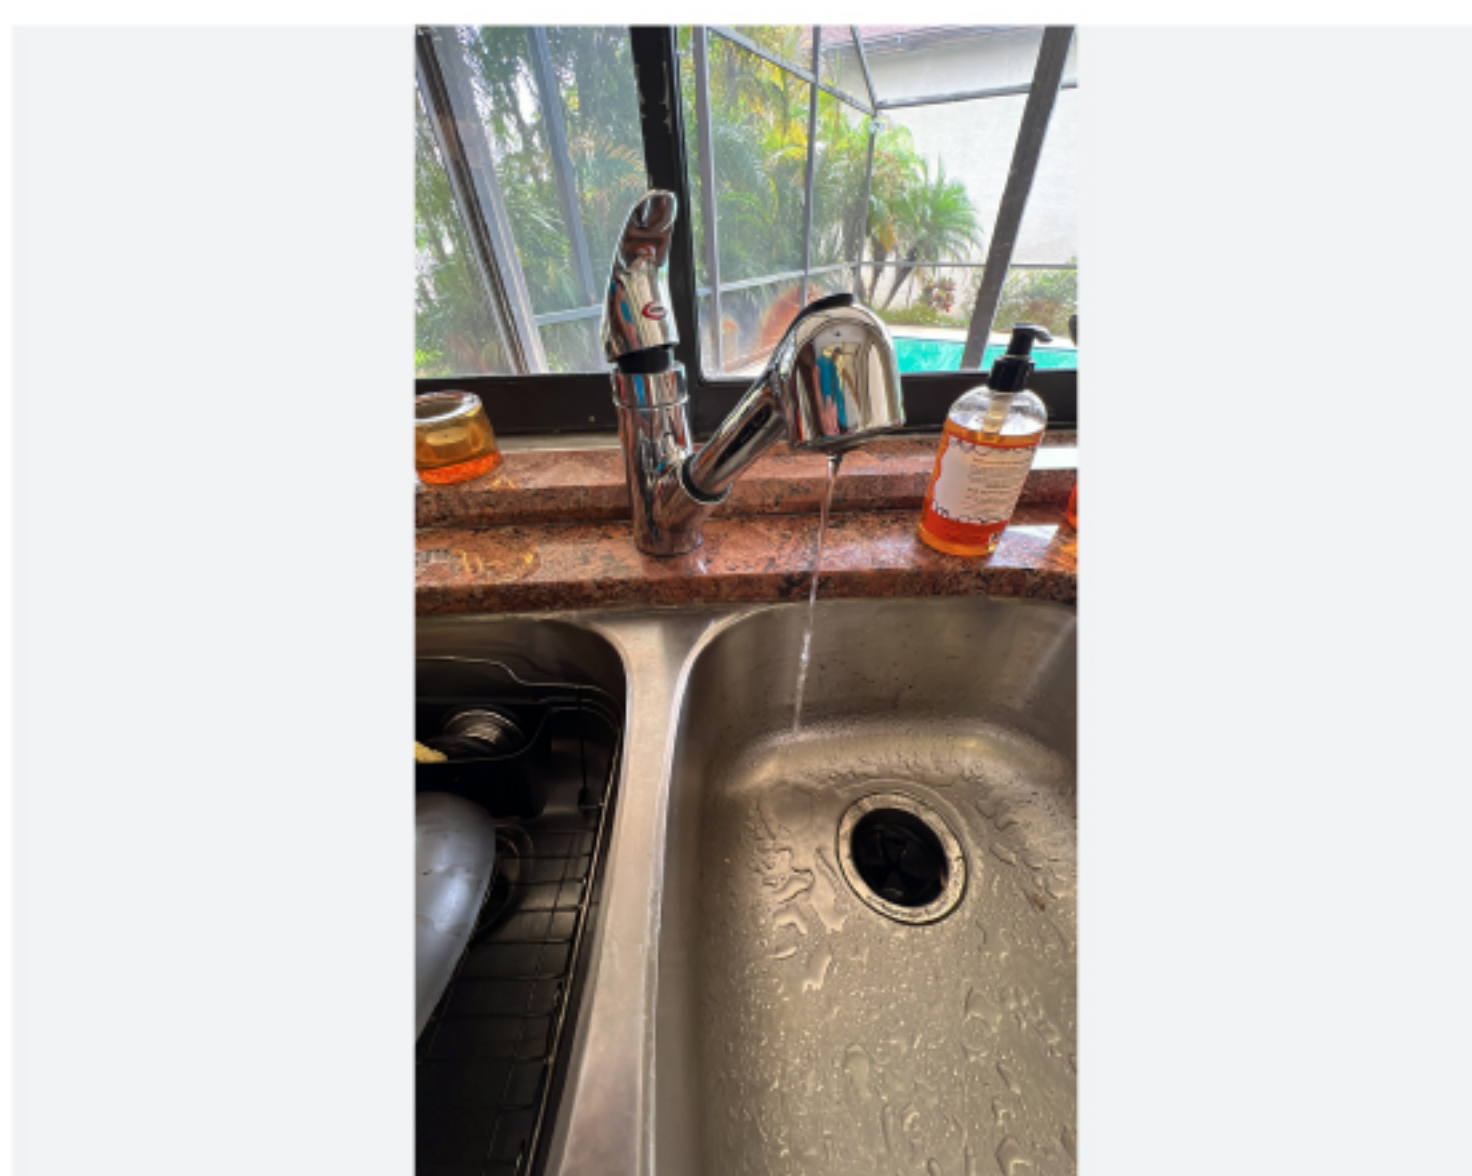
Location - Kitchen

- **Low Water Pressure**  
Low water pressure was noted at the kitchen sink when the water filtration system backflushes. Recommend evaluation and repair by a licensed plumber.

Requires Attention
